The demolition of the restaurant inside Queen's Fort of Tarragona (Spain)

British General James Stanhope reached Tarragona in 1709. He wanted to establish a naval base, in order to give military support to Archduke Charles of Austria in his dispute for the throne of Spain with Philip V. The "Fortí de la Reina" (Queen's Fort) is part of the overall project for the city fortification, led by Austrian and British; its position defended the northeastern end of Miracle Beach. Between 1988-1992 a large restaurant (about 2500 m²) was built within the walled perimeter of the Fort; it recreated a Romanesque cloister using GRC panels (glass fiber reinforced concrete), an architecture totally incongruent with the austere 18th century military structure in which it was housed. After various legal disputes, in 2007 a court ordered the demolition of the restaurant to return, as much as possible, the Queen's Fort to its previous state. In this paper we describe this demolition work.

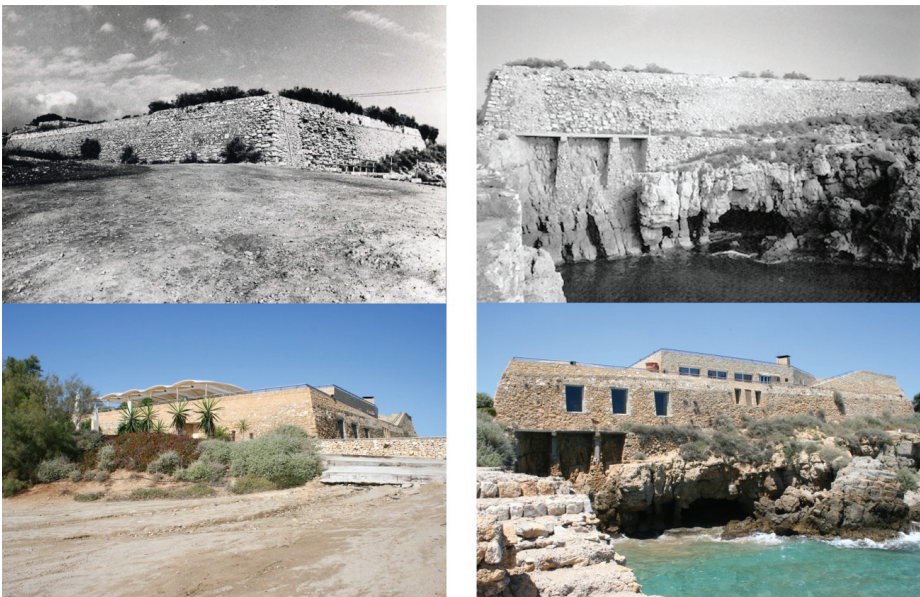
Figure 2. Queen's Fort transformation due to the construction of the restaurant. Comparison between historical images and its appearance in 2007.

- The original section of the wall was altered in order to increase the inner surface of the enclosure. Inner embankments were emptied, and concrete blocks retaining walls were constructed to stabilize the outer sloping masonry wall.
- Various openings in the wall were performed: six windows and three emergency exits.
- Exterior walls were raised to disguise the upper floor volume.

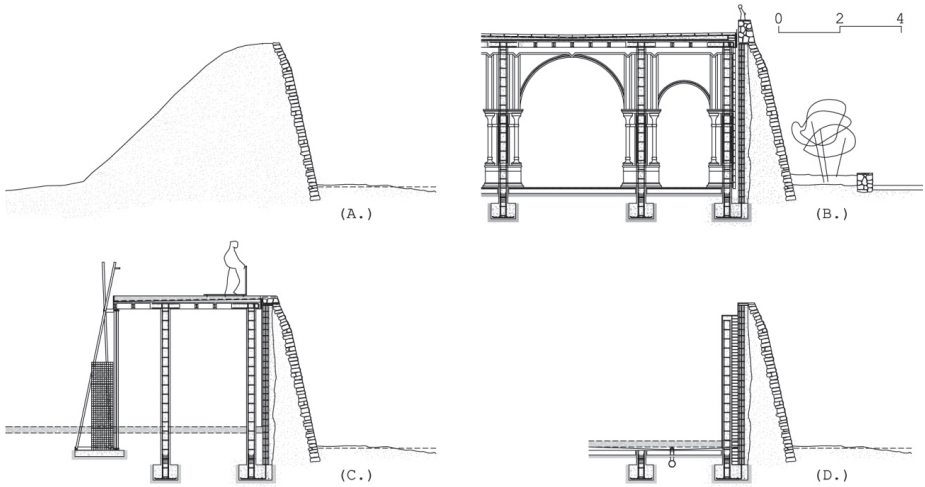
Figure 5. Section of the walls of the Fort: original (A.), alteration caused by the construction of the restaurant (B.), demolition and consolidation project (C.), after the demolition of the restaurant (D.).

It was necessary to underpin some of the retaining walls of the restaurant, particularly in a broad section of the east façade, and to ensure the stability against the push of the outer wall the restaurant pillars attached to them were preserved, to a height slightly below its crowning. Walls and pillars were coated with a protective layer of lime mortar.

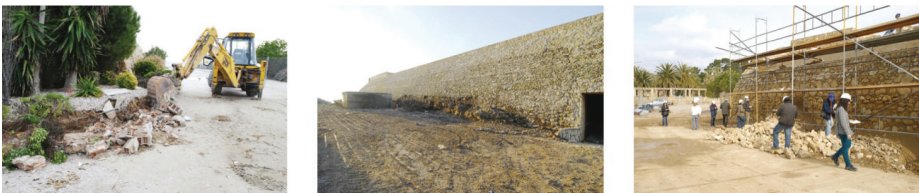
Much of the outer contour of the walls was occupied by decorative vegetation that impeded an overview of the exterior. These plantations and its boundary walls were removed. An ornamental fountain on the north façade was also demolished. In this same façade, some walls adjacent to the main gate's stone tower were preserved. Even though part of the original structures were not documented in pictures of the early 20th century, it was understood that they had historical value, since they possibly defined the beginning of the road that connected the Queen's Fort directly to the neighboring San Jorge's Fort.

Figure 8. Preliminary work developed out of the walls.

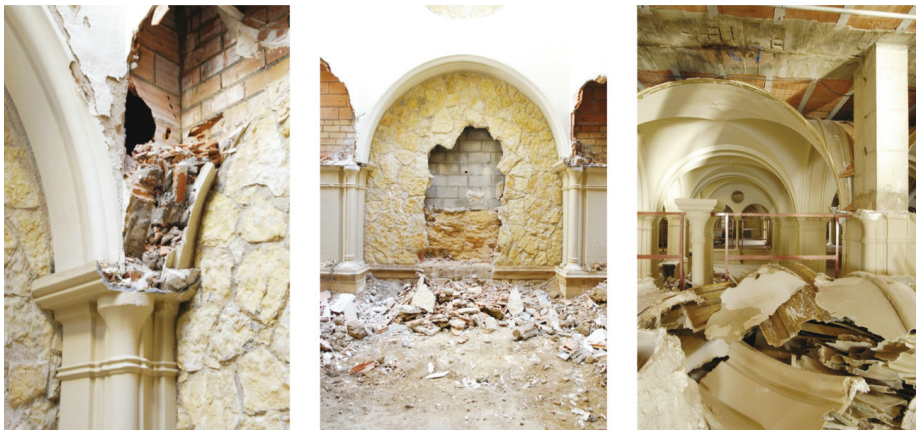
First, glazing and carpentry that were not required to close the worksite were removed, in order to facilitate the extraction of materials. Then, decorative veneers were dismantled, a particularly laborious operation due to the profusion of GRC panels decorating the restaurant's walls and ceilings, creating a Romanesque atmosphere (in an 18th century building...). The pavement stone tiles of the interior rooms and terraces were manually removed and stored for reuse.

Figure 9. Dismantling decorative veneers.

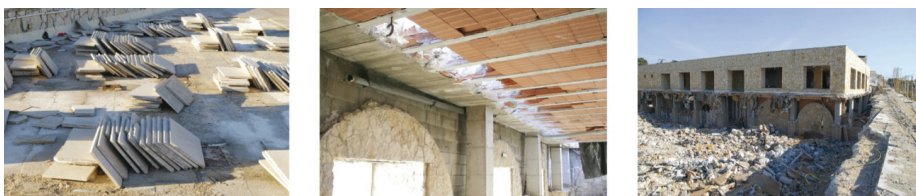
One of the main criteria was to avoid transmitting vibrations to the original structures. To achieve this, the contacting joints between the restaurant and the walls of the Fort were demolished manually. Once both structures were unrelated, mechanical means were used to deconstruct the modern ones.

Figure 10. Manual removal of the terrace stone tiles (left), disconnecting the structure of the restaurant from the perimeter of the wall (center) and demolition of restaurant structures (right).

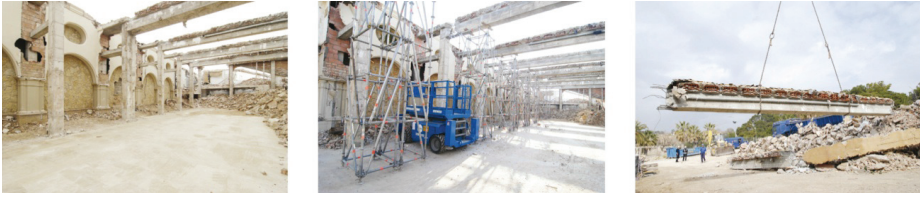
Solid concrete elements (columns and beams) were cut with diamond disks and extracted in large parts to the outside of the enclosure. Especially delicate was the removal of the large beams covering the banquet hall of the eastern half of the ground floor: they had a span of almost 15 meters, with a rough section of 40x80cm and a weight of about 12 tons. A shoring system allowed to unload the supporting pillars, then the beams were lifted by a large crane and deposited on the outside, where they were divided into smaller pieces for transport.

Figure 11. Dismantling and removing the large beams from the east hall.

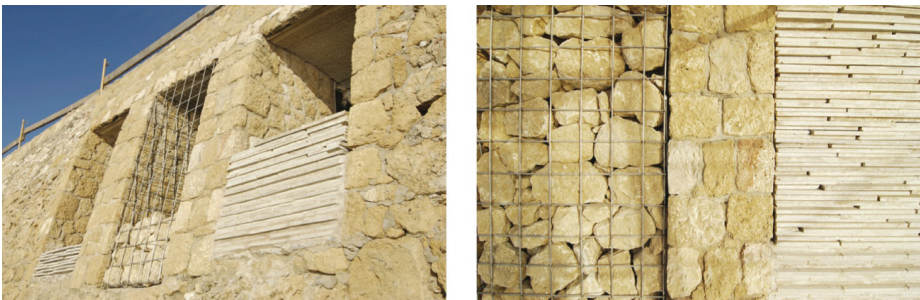
Windows and doors opened in the wall during restaurant construction were closed. To allow reconnaissance of the alteration, it was decided to keep the jambs and lintels clad in local stone arranged mimetically with the rest of the facing. It was taken into account that extraction could destabilize the wall, and in fact it was difficult to identify the gap between the original parts and the mimetic coatings. Various solutions were tested for walling up:

Figure 13. Tests for the outer walled up.

- Stainless steel gabions filled with stones debris from restaurant dismantling. This was the original option in the project. We understood that this allowed to preserve the overall colour unity of the facades, while the intervention was clearly perceived: the stones were placed without mortar, and his view was screened by steel grid. On the other hand, it permitted easy removal, if necessary, to reopen one of the emergency exits in the future.
- Stone tiles extracted from restaurant pavement, arranged in dry or with a thin layer of mortar.
- Stones recovered from the demolition and grouted with lime mortar.

Although the first two options seemed to us more appropriate, the Culture commission of the Generalitat de Catalunya considered both inadequate, and gave only its approval to the third solution.

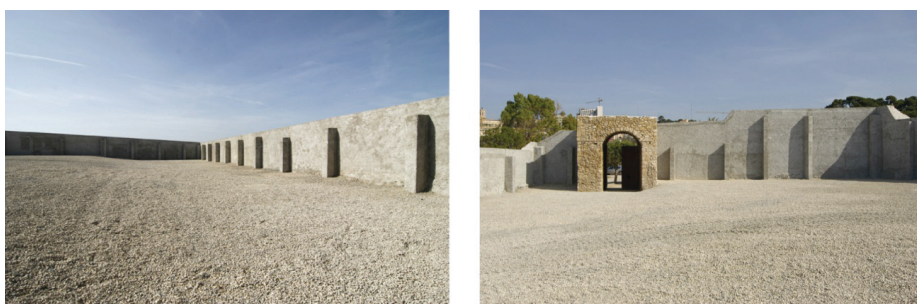
Figure 14. Interior of the Fort after the demolition and consolidation works.

The inner paving was solved reusing demolition materials to create a smooth transition between the two platforms on the ground floor (lowest to highest from west to east). To avoid accumulation of water inside the enclosure, the existing sewer system was reutilized, and expanded with various branches and scuppers.
