International Journal of Heritage and Sustainable Development

Vol. 4, No. 1, 2015, pp. 183-191

## Assessment of the stability conditions of an ancient stone masonry tower

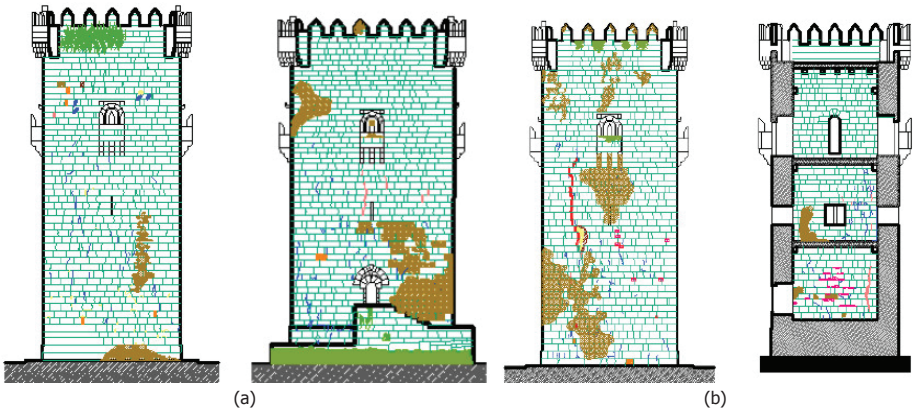
A preliminary visual inspection was carried out in order to locate and map visible damages in order to understand its distribution and to have a general idea about the reasons why the damages occurred. The damage maps were prepared with the help of the existing drawings that were obtained as blueprints, which dated back to 1983. Figure 3 illustrates the location and distribution of the damages and decay observed.

Figure 3. General view of the damages in the tower's facades: (a) southeast and (b) southwest facade and the (c) northwest facade and the (d) interior view of the northwestern wall.

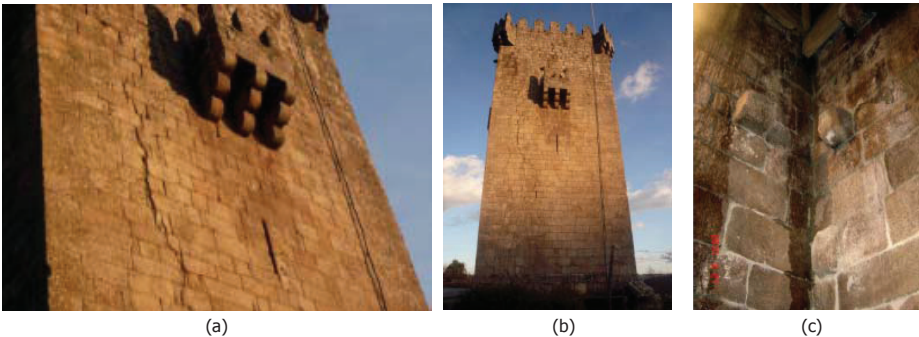
Generally, the damages and decay were mainly cracking and weathered material (Fig. 4). Relatively to cracks, structural and nonstructural cracks were observed. The most important cracks concentrate in three different locations of the tower and are known to exist before the intervention in 1982. The most important structural damage is found on the northwest façade, which exhibits a vertically extending crack, which is thicker on the second floor level on the exterior façade. The crack has an estimated width of 2cm. Historical survey showed that the crack exists since the 1980s. This crack was repaired with a thick mortar during an anterior restoration intervention. Around those cracks are visible some thin cracks that started to appear after the first intervention. However, the main repaired crack did not showed to have reopened.

Figure 4. Detailed view of the damages in the tower: (a) main crack and (b) water infiltration.

Material decay was observed in timber elements (biological attack, water infiltration, moist spots) and in stone units (biological growth, stains due to humidity, water infiltration, vegetation). The decay in the timber beams placed under the timber slabs caused some deformations. In fact, water infiltration and biological attack are the main problems regarding decay on the timber elements. The stone units suffer from the erosion and spalling, mainly concentrated of the ground floor.

The visual inspection resulted in the verification that the main crack extending along the second floor does not seem to be active after the repointing intervention in 1982, although further tests and monitoring are necessary to confirm this assumption. The overlapping of the damage maps showed that the thin vertical cracks observed are following the same pattern of the main external crack. The possible reason of these vertical cracks could be due to soil settlement. Apart from this problem, no out-of plane or any kind of similar phenomena is observed by visual inspection, which implies that the tower does not seem to present severe structural problems.

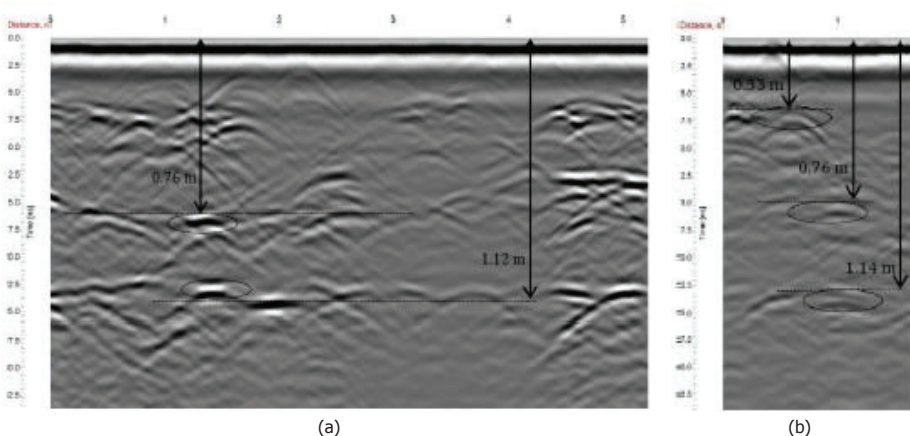
From the analysis of the acquired profiles, stones of irregular geometry were observed, as illustrated in Figure 5 but a three leaves masonry constitution was confirmed. The inner layer seemed to be the most irregular of the three leaves, composed approximately by stones with thicknesses varying between 0.26 and 0.40m. The outer leaf presents a more regular structure, with values close to 0.40m of thickness. Consequently, the infill dimensions ranged from 0.70 to 0.80m. Certain radargrams exhibited a certain decrease in the amplitude of the signal with depth. This loss of information can be attributed to the presence of humidity, which was well observed by visual inspection.

Figure 5. Radargrams carried out in the walls of the tower. Examples of an (a) horizontal and a (b) vertical profile are illustrated.

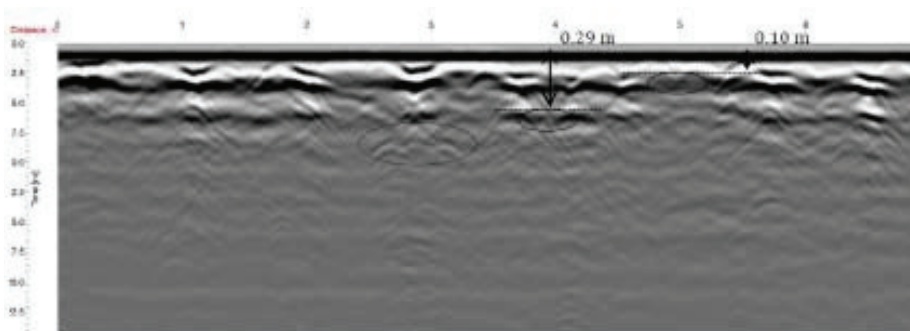
The slab of the tower is constituted by stones with relative similar longitudinal sections. As result of the GPR test (Fig. 6), the pavement slab thickness could be determined and also the thickness of the leveling slab for these stones. Regarding the supporting system, the obtained results were not much conclusive; however they may indicate the presence of a supporting structure.

Figure 6. Radargram carried out in the ground slab of the tower.

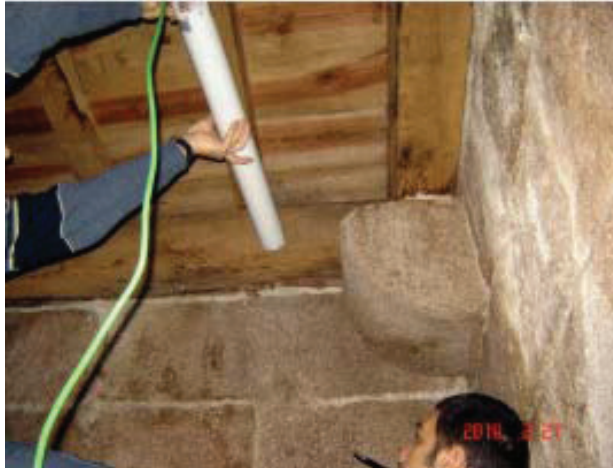
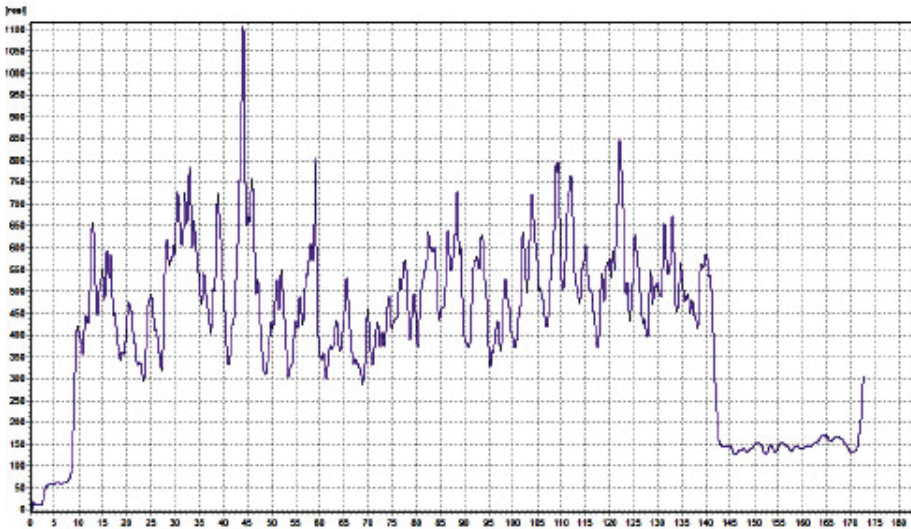
Figure 7. Application of the resistograph in wood beams and an example of the final result.

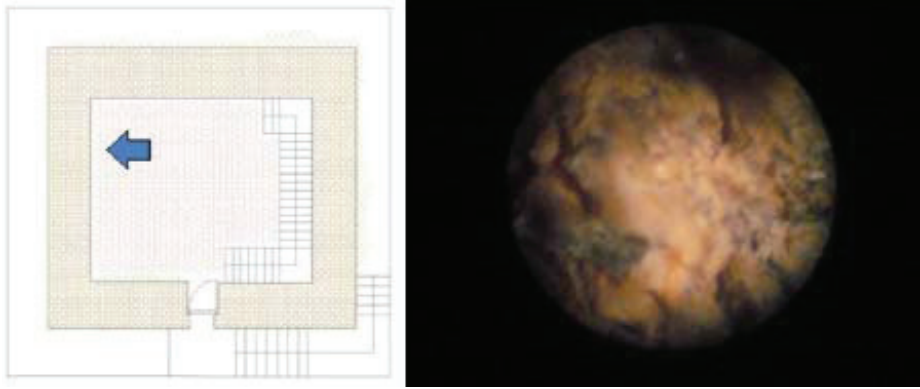
order to observe the thickness of the solid granite leaf as well as the depth of the inner layer, which was found to be approximately 0.4m, confirming the GPR results. This is illustrated in Figure 8.

Figure 8. Inspection with boroscopic camera: location and image from the inner leaf.

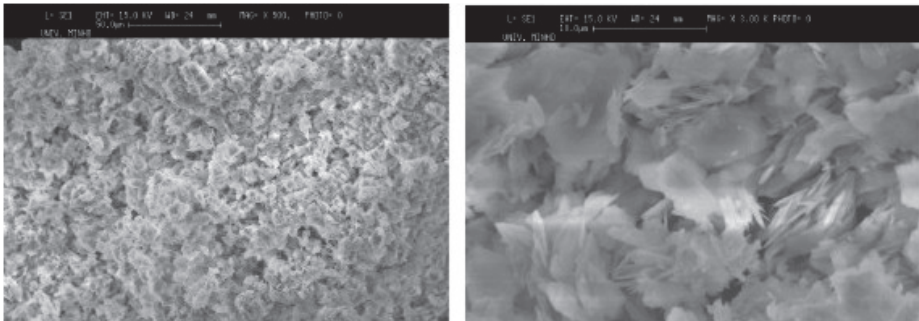
Ultrasonic pulse velocity tests were carried out in situ and in laboratory. The average velocity found was 2500 m/s, which is characteristic of a stone with some degree of deterioration (Vasconcelos et al., 2007). Additional analysis of the surface of the stones by scanning electron microscope (SEM) showed evidences of weathering, as illustrated in Figure 9.

Figure 9. SEM images from the surface of the stone.

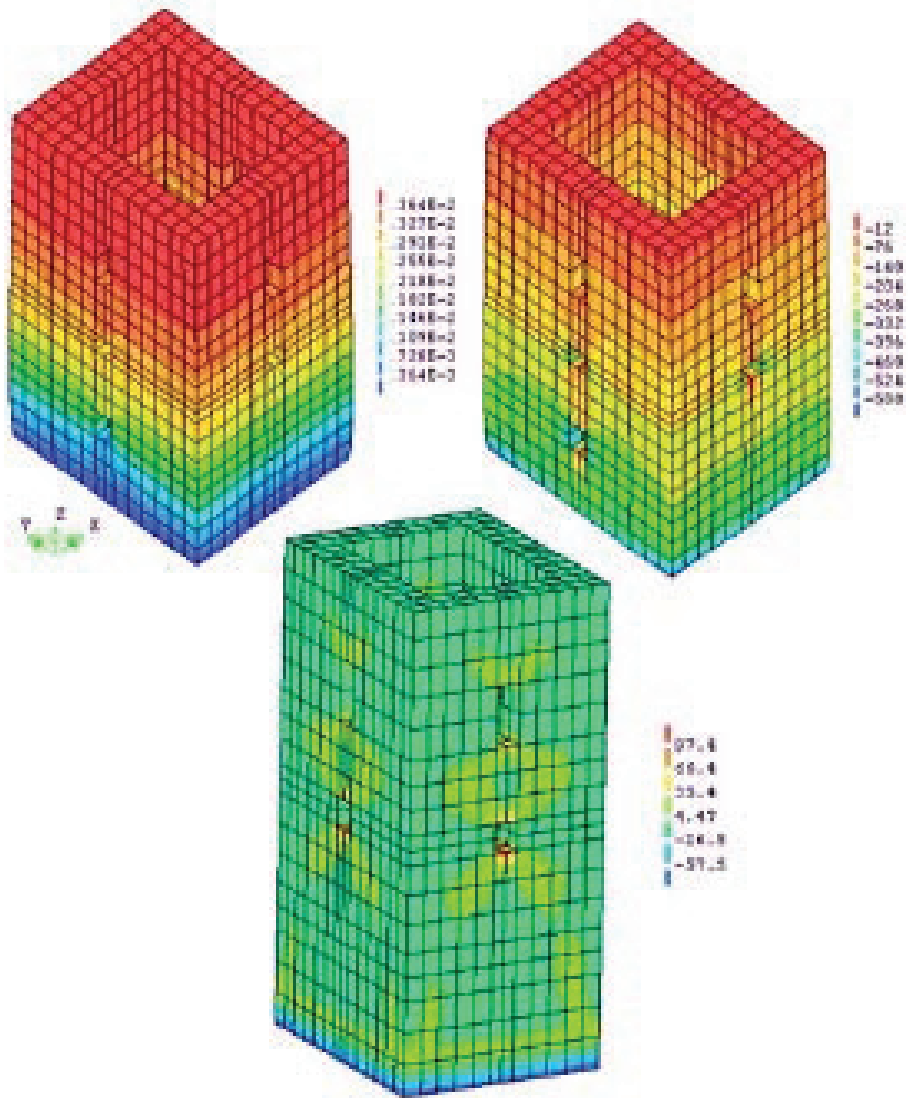
After calibrating the model, deflections and stresses were checked in an updated linear elastic analysis. As handcheck calculations anticipated, low compressive stresses were found in the results, where maximum compression stresses values of approximately 1MPa were obtained. Figure 11 shows the stress level in all the tower. It can be observed that maximum tensile stresses occur mainly around openings.

Figure 11. Updated FEM model for the tower showing stress levels.
