Analysis of traditional building techniques and damage assessment of traditional Turkish house - "case study of timber framed Kula houses"

Mine Tanaç Zeren

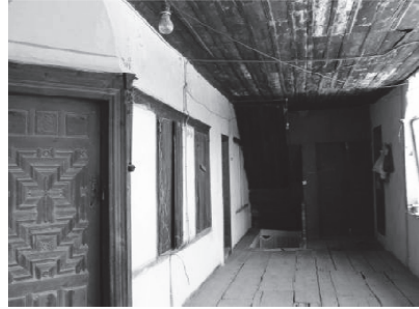
Figure 40. Case03 Situation of external sofa space, deterioration of the wooden material of sofa ceiling.

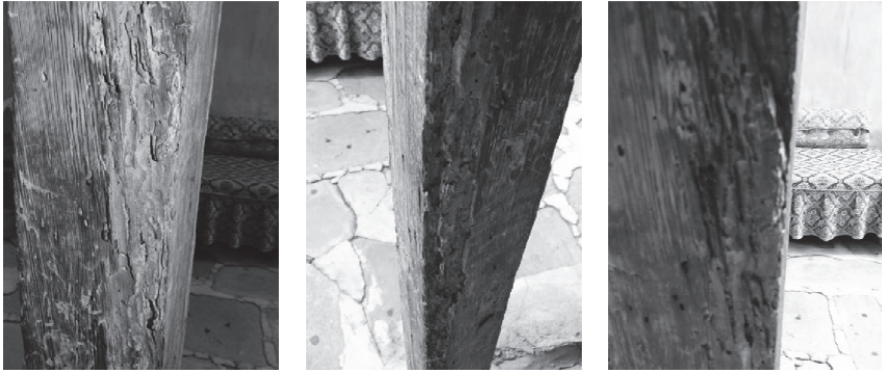
The deterioration types that have been identified can be listed as, fungi attacks, infestation, material loss, color changes. There are fungi attacks, color changes and infestation on the post elements carrying the Sofa. There are material losses and color changes on the coverings of the eaves. There is deflection on the first floor carrying system, and some material losses and color changes on the floor coverings.

Figures 44, 45 & 46. Case04 Deterioration Problems of the Posts (Color change, holes caused by insects and sectional material loss).

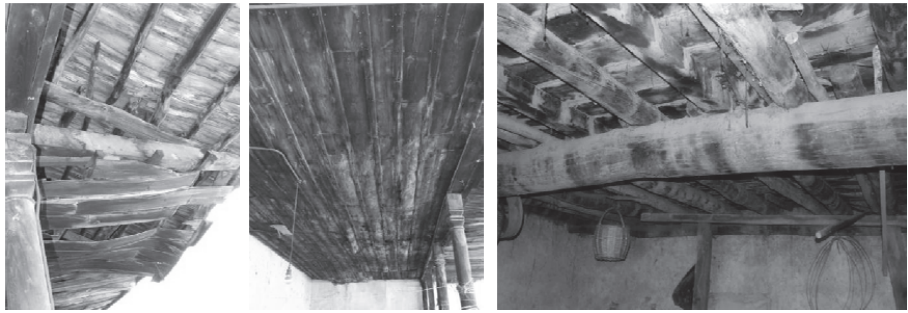
Figures 47, 48 & 49. Case04 Deterioration Problems of the Roof and Floor (Color change).

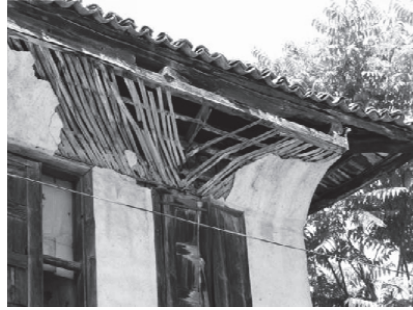
The house is in good condition in the general point of view. Deterioration can be seen within the building is some material loss on the eaves of the building. A second thing can be seen within the building is a wrong restoration attempt example which is a one storied space added under the sofa space of the building and this space demolishes the space organization of the ground floor.

Figure 56. Case07 Material Loss on the Eaves of the building.

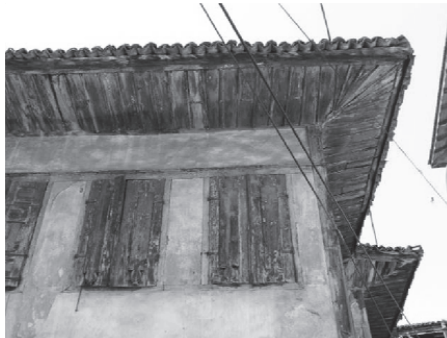
Figures 59 & 60. Case08 Deteriorations on façade.

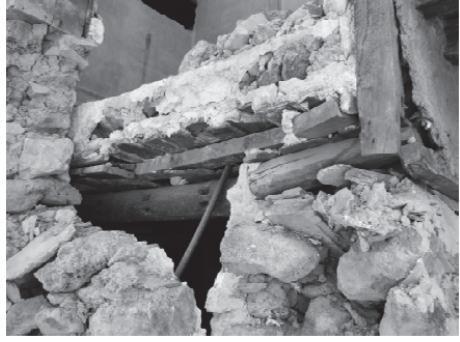
The main deterioration factor can be seen within the case is suffering from humidity. Humidity caused color changes, fungi attacks on timber element. Different from other cases, insect invansion can be obtained in this case on the timber beam elements that support the masonry stone wall. The insect invansion fragmented and reduce the cross section dimension of timber elements.

Figure 62. Case09 The deteriorated timber elements and masonry wall.

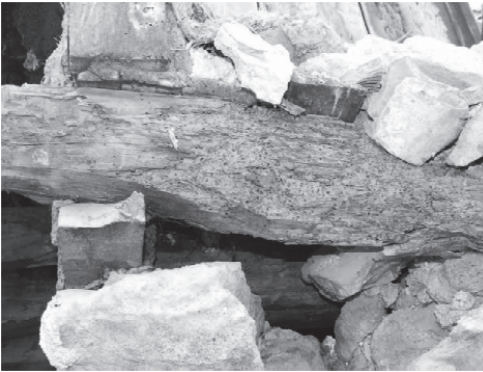
Figure 63. Case09 Case09 The reduced cross-section timber element, causes of insect invansion.

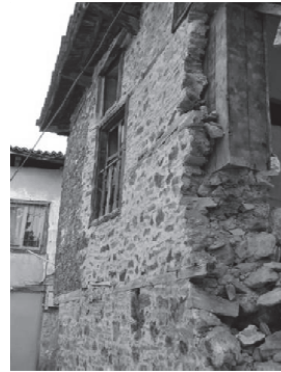
The building is an external sofa typed, two storied house with a courtyard. The construction system of the ground floor is stone masonry supported by timber post beams (Hatıl Constructiob Type); second floor of the building is timber frame structure. The building is desolated and because of that reason the masonry wall facing the street has collapsed. Especially the deteriorations on timber elements caused deformation of the structural system.

Figure 64. Case09 The collapsed part of the house.
