International Journal of Heritage and Sustainable Development

Vol. 4, No. 1, 2015, pp. 141-147

Interpretation and preservation of archeological sites from their building construction techniques. The case study of S. Maria in Portuno in Italy

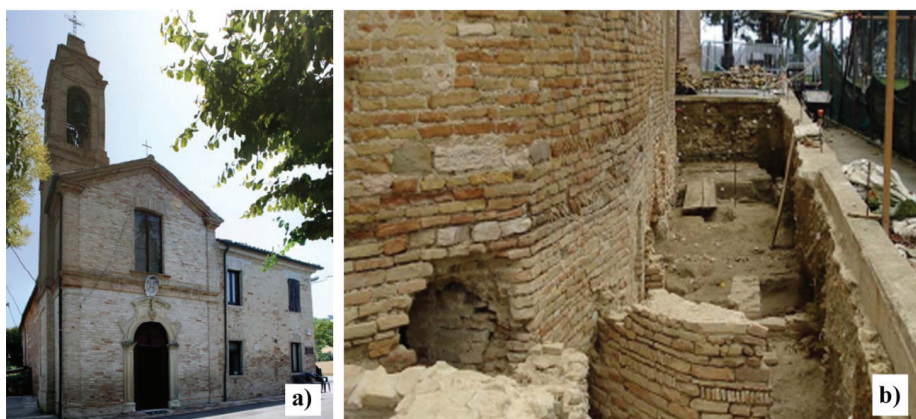
Figure 1. Some views of the S. Maria in Portuno's site: the church (a) and the northern zone of archaeological excavations (b).

The S. Maria in Portuno's archaeological site (Corinaldo, Marche region, Italy) is located in the centre of Italy near the Adriatic sea (Fig. 1). It is positioned along a road axis that coincides with an ancient Roman road and it was investigated, since 2001, by a series of different archaeological investigations as shown in Giorgi and Lepore (2010) and Lenci et al. (2011). From these investigations an on-site continuity of human settlements seems to come out, allowing to identify five main building phases of the site from the Roman Age to the current period (Giorgi and Lepore, 2010): (1) the productive site in the Roman Age, confirmed by the well-preserved walls of the Roman kilns used to carry out bricks and tiles; (2) the construction of a

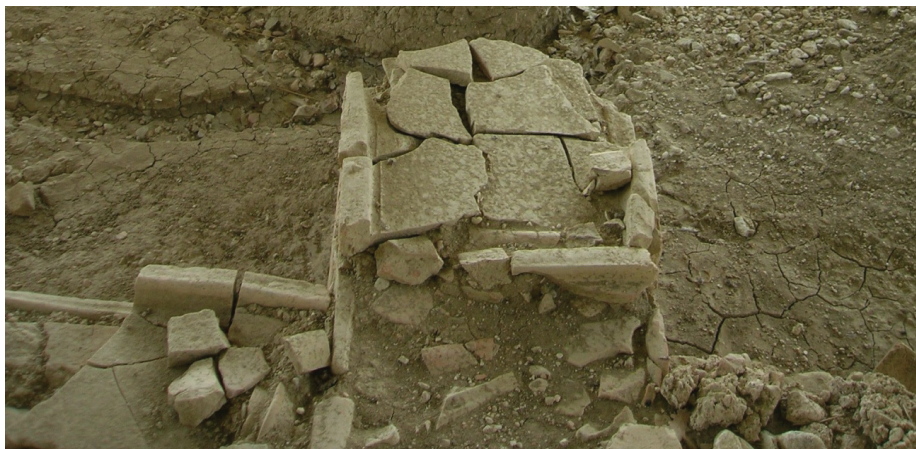
Figure 5. Well-preserved ruins of some local Roman masonries made by flat tiles near the S. Maria in Portuno's site (Suasa's archaeological site).

In this way, the considered construction technique allowed in the Middle Age (11th century A.D.) to build bearing masonries with regular sides starting from ceramic fragments characterized by irregular shapes. Moreover, this peculiar construction technique is very similar to a local Roman one, where the masonry lay-out at the elevation level is arranged in the same way by two types of horizontal layer, piled one above the other (Fig. 5). The only difference is that the first one is made up of a whole U-shape flat tile across the thickness with the raised edges towards the outside, so as to achieve an unbroken "U-shaped formwork" to be filled by the second layer. In this way, the results seem to demonstrate a continuity of the local building practice at least until the 11th century A.D. and the influence of the social and economic context on the building practice in the High-Middle Age, as shown in literature for other historical masonries (Tobriner, 2003).
