# International Journal of Sustainable Construction

Volume 2  
Number 1 - 2014

## Structural repair of decayed old timber end beams

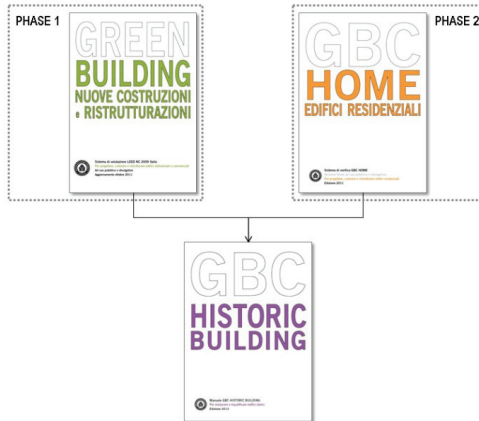
Figure 1. Existing GBC Italia's rating systems as basis of the new protocol.

In 2010, the Italian Green Building Council developed a local version of one LEED<sup>®</sup> rating system for New Construction and Major Renovation named LEED<sup>®</sup> Italia (GBC Italia, 2010). Although LEED<sup>®</sup> Italia is applicable to interventions of deep renovation of historic buildings, it does not include specific issues linked to the valorisation of historical and cultural aspects that the built environment might have. The new rating system is based on the type of building involved among the family of the existing products of GBC Italia for new construction (in particular the LEED<sup>®</sup> Italia 2009 *New Construction and Major Renovation and GBC Home* (GBC Italia, 2011)), progressively merge into a single product called *GBC Historic Building*<sup>TM</sup> (Fig. 1). The first one is used for residential building with more than four floors above ground or for commercial buildings, the second is only for low rise residential building (four floor above ground or less). Basing on these two protocols, the final output of the process is a unique, specific and dedicated tool that covers all potential cases of restoration and refurbishment (Fig. 2).

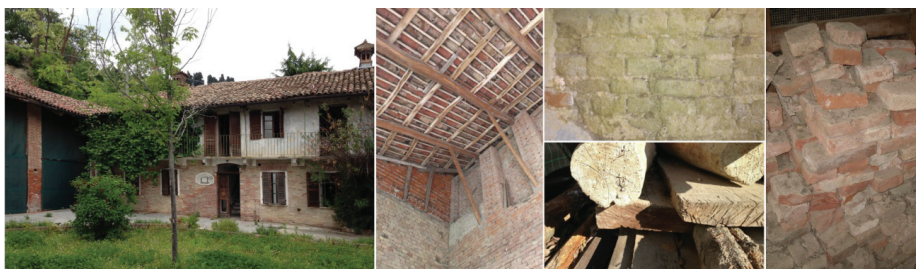
Figure 6. The rural building in Guarene (Italy) is the first registered case study of *GBC Historic Building™*.

The building has been built with a pre-industrial building process (local knowledge and operators), technologies (humid for walls and dry for floors and roofs) and materials (such as adobe bricks and bricks made locally) that are expression of a traditional building culture to be preserved (Fig. 6). With the support of TAG HB, GBC Italia is evaluating the case study documentation both of project and construction phases, including on-site inspections, and identifying critical aspects or necessary additions for the new protocol evaluation (Boarin, 2014, p.3).

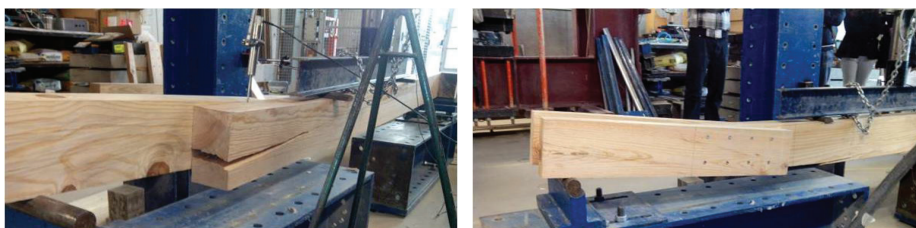
a) Wood splitting in series *O*b) Rotation of the joint in series *T*Figure 11. Failures modes observed in specimens of series *O* and *T*.

The efficiency of the repairing techniques for decayed timber end beams based in the use of new timber elements screwed to the original, was limited. In fact, due to the large de-formation demonstrated by the specimens tested within series *O* and *T*, the load-carrying capacity of these specimens is inferior to the expected value. In particular, the joint of specimens of series *T* have showed a behavior similar to a hinge (Fig. 11b). In other hand, the specimens of series *O*, with only one new timber element, have failed by wood splitting (Fig. 11a) due to tension stresses perpendicular to the grain that occurred in the row of screws located in the tension side (below the neutral axis). Those stresses could be prevent by local reinforcements but, it is important to point out that the geometry of the cross-section selected, with a reduce height, promotes this brittle behavior.

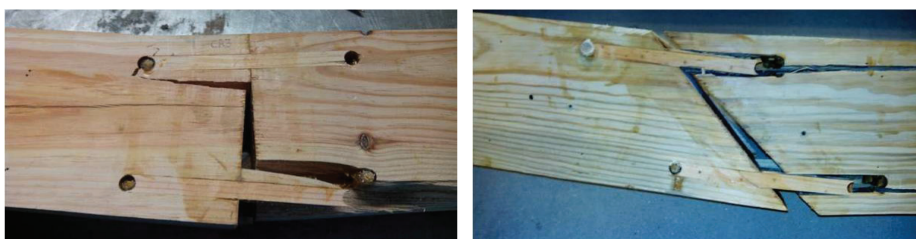
a) Series *GV*b) Series *GD*

c) Series *GM*d) Wood failure of specimens *GM1*Figure 12. Typical failures modes observed in specimens of series *GV*, *GD* and *GM*.

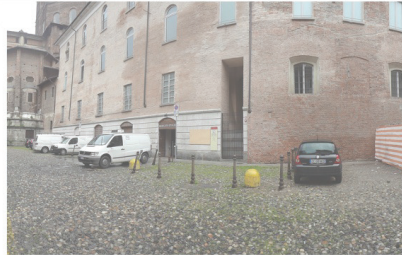
Piazza Cavagneria

**Criticità:**  
 Restringimento del passaggio a meno di 90 cm dovuto all'errato posizionamento delle autovetture nel parcheggio per residenti.

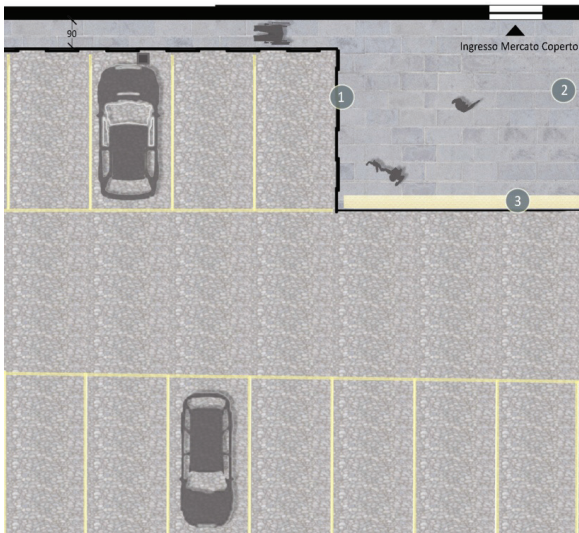
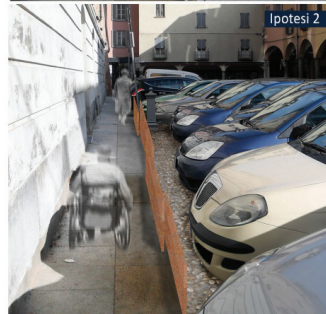
Figure 5. The technical drafting showing the solution to save the path from the cars parking in Piazz-a Cavagneria; the idea is to maintain no less than 90 centimeters between the wall and the cars in order to allow persons with wheelchair moving without any problem.

- 1) Posizionamento di cordoli dissuasori di altezza 40 cm.
- 2) Rifacimento della pavimentazione in corrispondenza dell'ingresso del Palazzo del Broletto.
- 3) Posizionamento Loges in corrispondenza dell'attraversamento

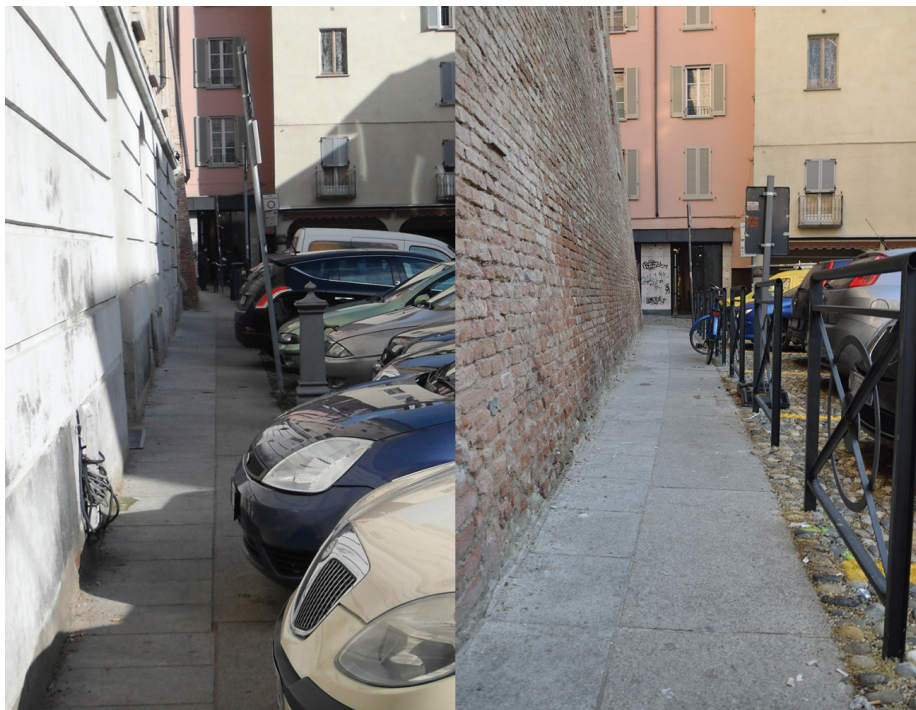
Figure 6. Piazza Cavagneria: how it was before and how it is now; the Municipality realized the idea we designed even if the elements to preserve the path are made by iron (in our project they were thought in corten) and their geometry is different (they are 1.10 m height while the corten panels in the project were 0.45 m).

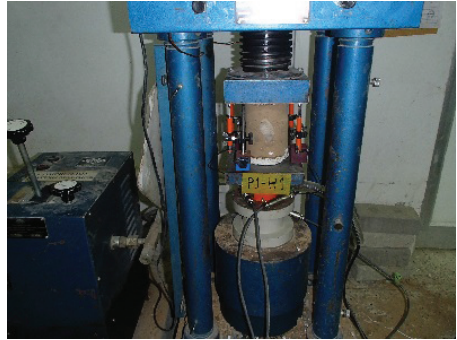
Figure 3. Overview of compressive strength test.

Figure 3 shows an overview of the material test. A compressive strength test and splitting tensile strength test were conducted for rammed earth core specimens according to the Standard Test Method for Compressive Strength of Cylindrical Concrete Specimens (ASTM C39) and the Standard Test Method for Splitting Tensile Strength of Cylindrical Concrete Specimens (ASTM C496). The compressive strength test was carried out using a compressive strength testing device (1000 kN) at the Bhutan Standards Bureau, a load cell (KCM-200KNA, Tokyo Sokki Kenkyujo Co., Ltd.), and a digital data logger and switching box (TC-32K and CSW-5A-05, Tokyo Sokki Kenkyujo Co., Ltd.). To determine the average deformation, the displacements at the four corners of rammed earth core samples were measured using displacement transducers (CDP-10MT, Tokyo Sokki Kenkyujo Co., Ltd.). The relationship between the load and the displacement was obtained from the data. The splitting tensile strength test was conducted using a load cell (KCM-20KNA, Tokyo Sokki Kenkyujo Co., Ltd.) because the tensile load is very small.

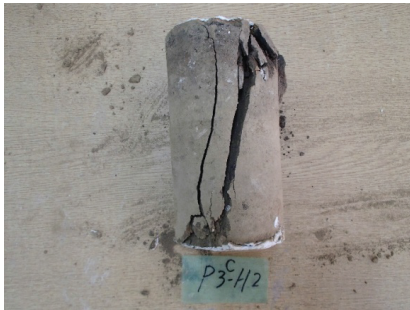
Figure 4. Compressive fracture mode.

Figures 4 and 5 show the example of the compressive fracture mode and the compressive stress and strain relationship, and Figures 6 and 7 show the density and compressive and tensile strength relationship, and compressive strength and Young’s modulus relationship for all samples, respectively. Table 1 summarizes the average results of the compressive and the splitting tensile strength tests. The average values for all samples extracted from each rammed earth block are shown. The compressive strength is estimated considering the scale effect of rammed earth core samples. The density ranges from 1573 to 2033kg/m<sup>3</sup> with an average of 1810kg/m<sup>3</sup>; the compressive strength, from 0.325 to 1.585MPa with an average of 0.845MPa; the tensile strength, from 0.027 to 0.220MPa with an average of 0.101MPa; the ratio of compressive to tensile strength *c/t* for each block, from 7.15 to 11.29 with an average of 8.45; and Young’s modulus, from 48.1 to 320.7MPa with an average of 123.5MPa. As the density increases, the compressive and the tensile strength and Young’s modulus tend to increase. However, the material characteristics of rammed earth differ depending on the construction method, and therefore, the test results vary widely according to the block number.

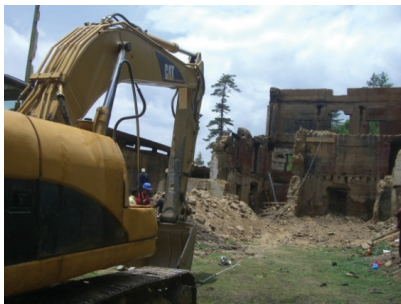
Figure 10. Overview of pull-down test.

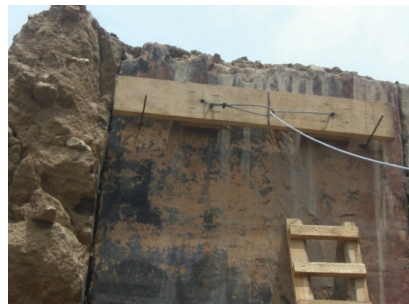
Figure 11. Wooden plate.

To avoid the local failure and to apply a distributed load on the wall, a wooden plate was placed on both the front and the back of the top of the rammed earth wall at the point where we applied the load; a hole was drilled through the wooden plate and the edge of the rammed earth wall for the wire to pass through, thus wrapping the rammed earth wall with the wire (Fig. 11). Wall-4 was pulled with two wires because of wire breakage during the pull-down test. The wire was attached to the forks of the backhoe to pull the rammed earth wall.

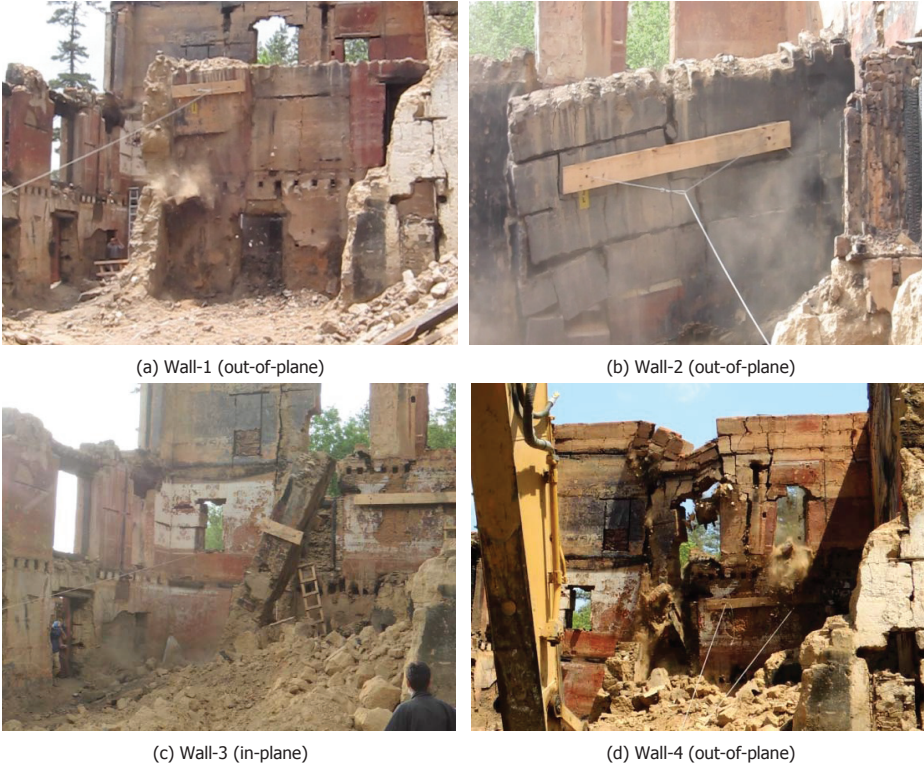
Figure 12. Collapse mode of rammed earth walls.

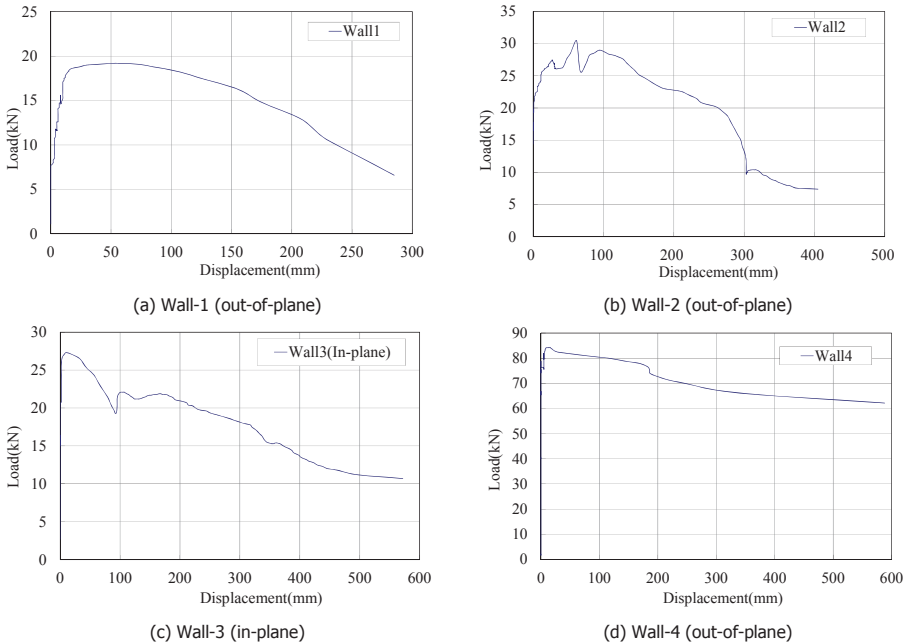
Figure 13. Load-displacement curve.

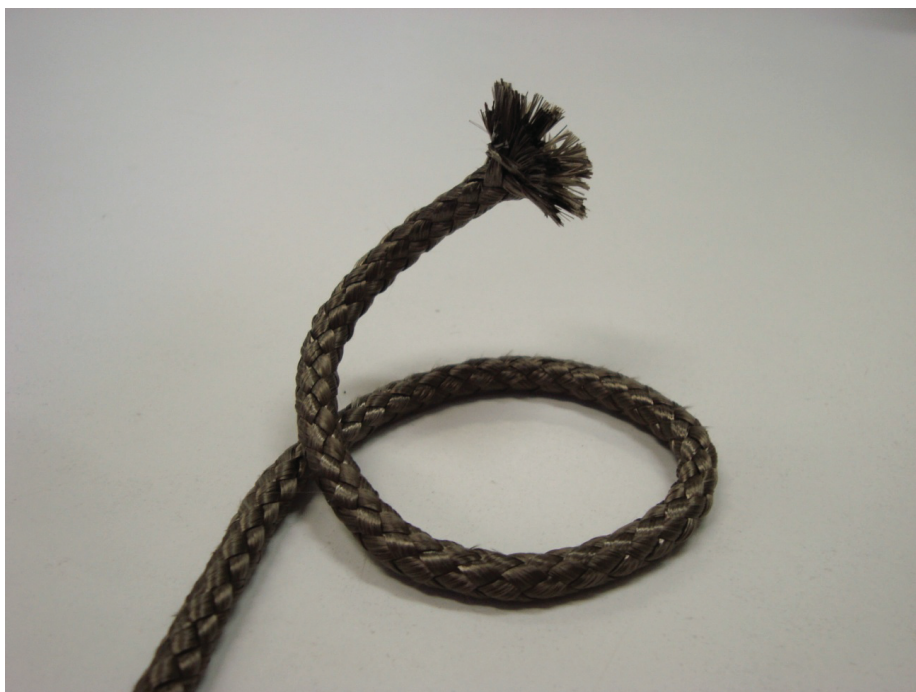
Figure 3. The basalt fibre rope.

Basalt is a natural material that is found in volcanic rocks originated from frozen lava. Continuous basalt fibers are obtained by melting basalt and are characterized by high modulus, heat resistance, good resistance to chemical attack and seem to be a good alternative to glass fibres (Van de Velde et al., 2003; Wei et al., 2010; Sim et al., 2005). In construction field, basalt is proposed in form of short fibres for insulating material (basalt wool), for reinforced concrete (chopped fibres) or like reinforcing material in restoration and rehabilitation of concrete (Sim et al., 2005) and masonry structures (Papanicolaou et al., 2011), or like reinforcing material for fibre reinforced polymer (FRP) bars used in concrete technology (Brik, 2003). It is also important the application in passive fire protection field (Landucci et al., 2009). Continuous basalt fibres can be processed with classic textile transformation to obtain also ropes, unlike other kinds of reinforcing fibres. Basalt fibres ropes of 4mm of nominal diameter (declared by manufacturer), have been used in this experimental program (Fig. 2). A mechanical characterization of this product has been developed by (Quagliarini et al., 2012c) and reported in Table 1.

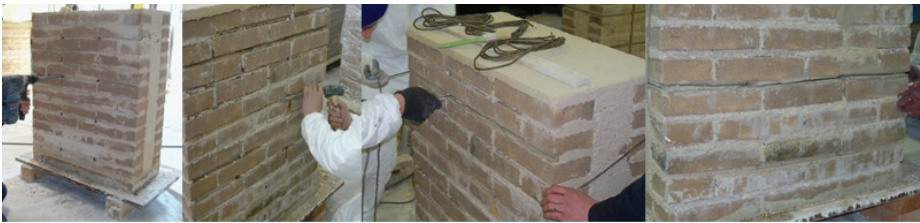
Figure 5. Operative phases for the application of "RO" reinforcement.

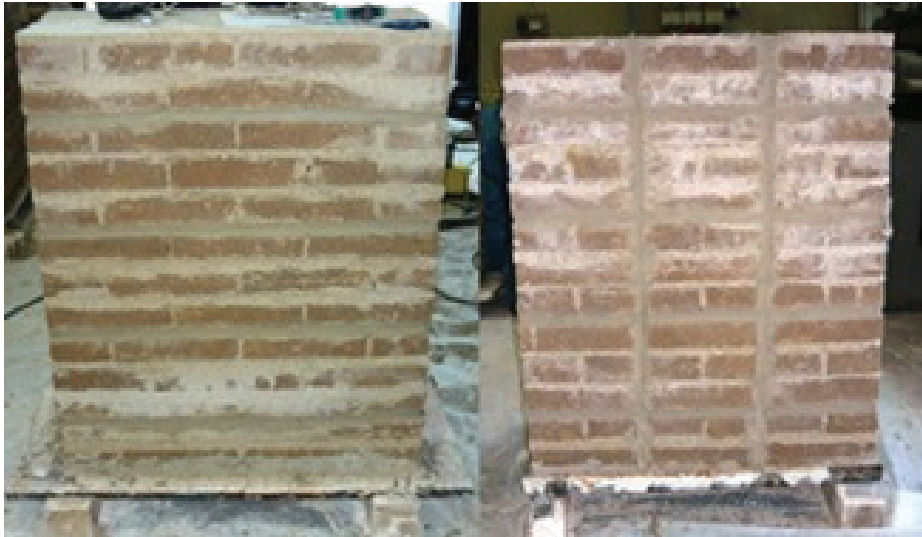
Figure 6. The final aspect of masonry wallets at the end of consolidating process. Sample after "RO" strengthening on the left and after the "RR" one on the right.

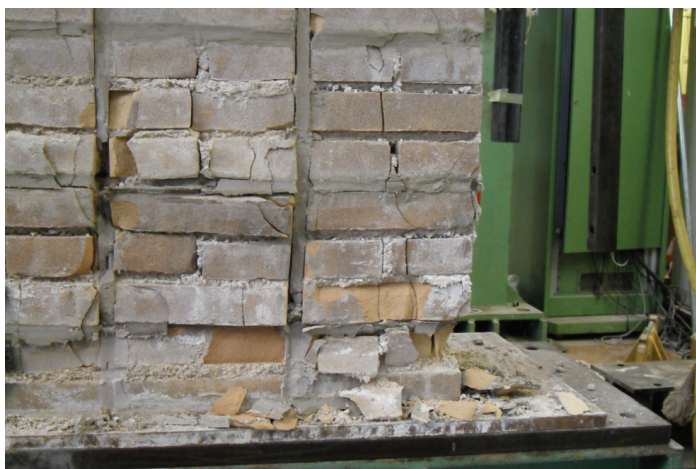
Figure 9. Cracks appeared on bricks of reinforced samples subjected to vertical compression test.

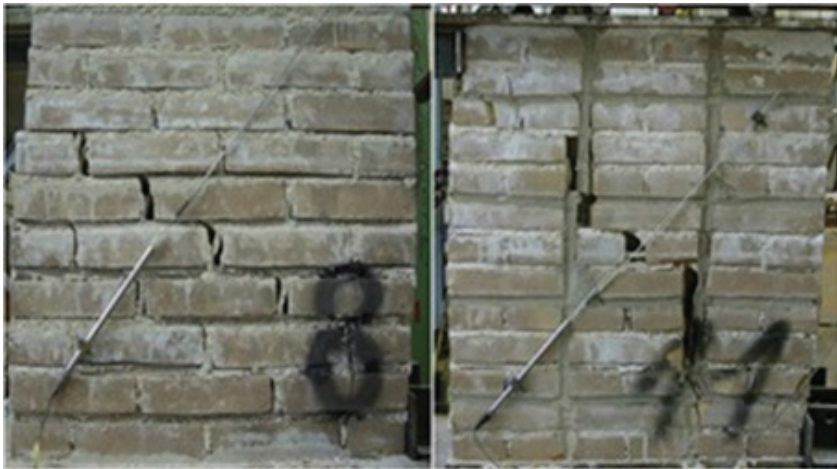
Figure 11. Three-leaf masonry samples after shear-compression test: on the left the unreinforced ones ("NC") and, on the right, the ones strengthened through BF arranged both horizontal and vertical bed mortar joints ("RR").

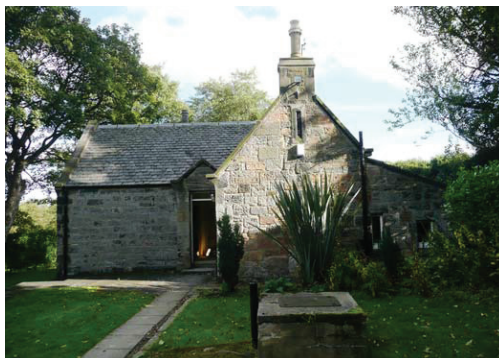
Figure 3. Wells O' Wearie facing north west.

Wells O' Wearie cottage is a small single storey detached building dating from the early 19th century, with an east - west orientation. The cottage is constructed of sandstone rubble, bound with lime, and finished with ashlar quoins and margins. The property is owned and managed by Historic Scotland (Curtis & Jenkins, 2012). It is located in Holyrood Park area of Edinburgh (Scotland) on a sheltered site below the road level (Fig. 3). Pre-intervention monitoring took place during October 2010 whilst the property was unoccupied.

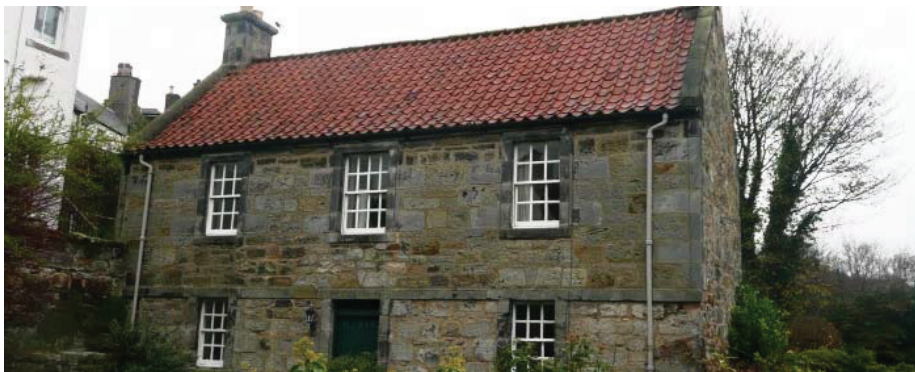
Figure 6. Front elevation of Wee Causeway Cottage.

The building is a detached cottage referred to as 'Wee Causeway' (Fig. 6), located in the village of Culross, Fife, cared for by the National Trust for Scotland.

The original fabric dates from the mid-18th century. It consists of a sandstone rubble masonry wall bound with lime, although has been re-pointed with cement in several areas. Internally the walls in the ground floor rooms are lined with lath and plaster, others have plaster 'on the hard' (i.e. directly onto the masonry). All rooms had a standard cornice detail in place (Curtis & Jenkins, 2013). It has a pitched pan-tile roof common to the east coast of Scotland and the windows are single glazed sash and case.
