Pull-down test of the rammed earth walls at Paga Lhakhang in the Kingdom of Bhutan

Introduction

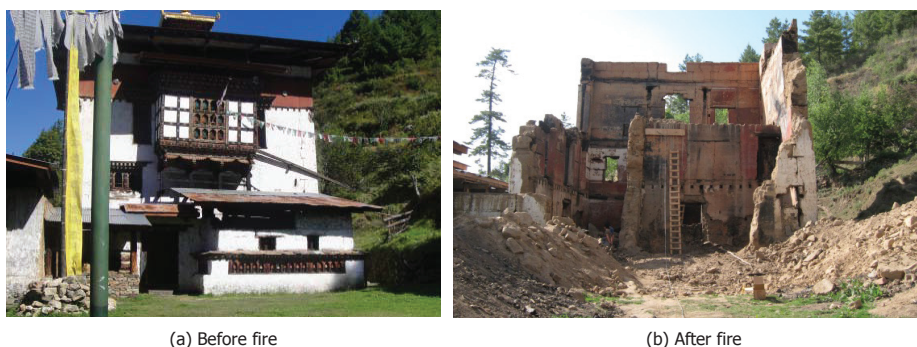
Figure 1. Front view of Paga Lhakhang.

Paga Lhakhang is located on a mountain slope facing the Wangchchu River in Chhukha Dzongkhag, southern Bhutan (Fig. 1 (a)). It is believed that Paga Lhakhang was built in the middle of the 18th century by Kuenga Gyamtsho. However, according to a priest there, it was built 400 years ago. For now, the time of construction remains unclear. Paga Lhakhang was burned down by a fire due to a short circuit in the early morning of February 29, 2012. After the fire, only the inside and outside walls remained (Fig. 1 (b)). Details about the building are unavailable because little investigation data could be obtained after the fire. However, the building was considered to have four stories above ground, with a base made of stone, frame made of rammed earth, and floor frame made of wood.

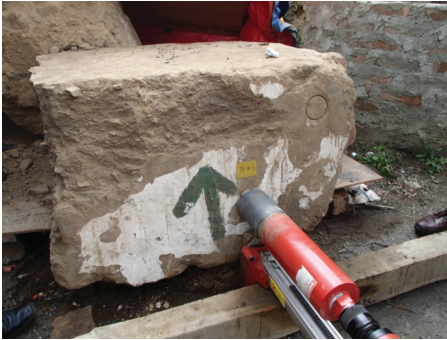
Figure 2. Rammed earth block.

Material tests were conducted on rammed earth core samples to determine the compressive and tensile strength and Young's modulus. These samples were extracted from the four remaining rammed earth blocks at Paga Lhakhang using a hand core drill machine (DD-120, Hilti Corporation), as shown in Figure 2. 3–7 samples with a diameter and length of 100 mm and 100–200mm, respectively, were obtained from each block. The samples were irregularly shaped owing to processing difficulties. Therefore, they were shaved off and capped with plaster to make them almost flat on both the top and the bottom surfaces.

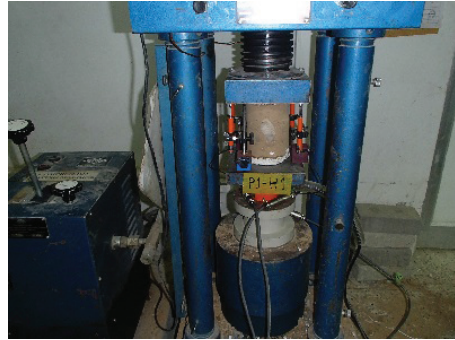
Figure 3. Overview of compressive strength test.

Figure 3 shows an overview of the material test. A compressive strength test and splitting tensile strength test were conducted for rammed earth core specimens according to the Standard Test Method for Compressive Strength of Cylindrical Concrete Specimens (ASTM C39) and the Standard Test Method for Splitting Tensile Strength of Cylindrical Concrete Specimens (ASTM C496). The compressive strength test was carried out using a compressive strength testing device (1000 kN) at the Bhutan Standards Bureau, a load cell (KCM-200KNA, Tokyo Sokki Kenkyujo Co., Ltd.), and a digital data logger and switching box (TC-32K and CSW-5A-05, Tokyo Sokki Kenkyujo Co., Ltd.). To determine the average deformation, the displacements at the four corners of rammed earth core samples were measured using displacement transducers (CDP-10MT, Tokyo Sokki Kenkyujo Co., Ltd.). The relationship between the load and the displacement was obtained from the data. The splitting tensile strength test was conducted using a load cell (KCM-20KNA, Tokyo Sokki Kenkyujo Co., Ltd.) because the tensile load is very small.

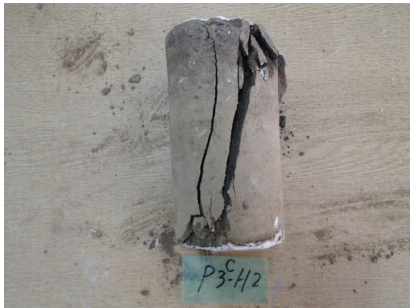
Figure 4. Compressive fracture mode.

Figures 4 and 5 show the example of the compressive fracture mode and the compressive stress and strain relationship, and Figures 6 and 7 show the density and compressive and tensile strength relationship, and compressive strength and Young’s modulus relationship for all samples, respectively. Table 1 summarizes the average results of the compressive and the splitting tensile strength tests. The average values for all samples extracted from each rammed earth block are shown. The compressive strength is estimated considering the scale effect of rammed earth core samples. The density ranges from 1573 to 2033kg/m³ with an average of 1810kg/m³; the compressive strength, from 0.325 to 1.585MPa with an average of 0.845MPa; the tensile strength, from 0.027 to 0.220MPa with an average of 0.101MPa; the ratio of compressive to tensile strength *c/t* for each block, from 7.15 to 11.29 with an average of 8.45; and Young’s modulus, from 48.1 to 320.7MPa with an average of 123.5MPa. As the density increases, the compressive and the tensile strength and Young’s modulus tend to increase. However, the material characteristics of rammed earth differ depending on the construction method, and therefore, the test results vary widely according to the block number.

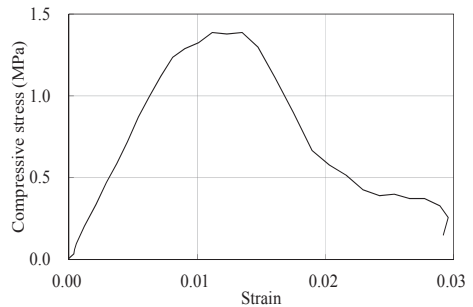
Figure 5. Compressive stress and strain relationship.

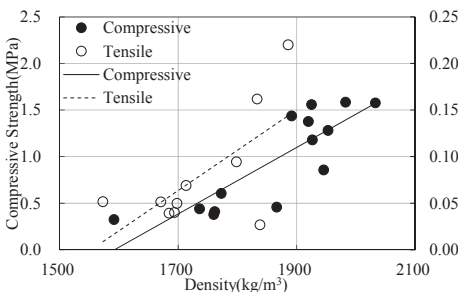
Figure 6. Density and compressive and tensile strength relationship.

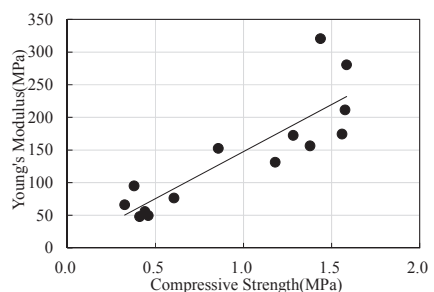
Figure 7. Compressive strength and Young’s modulus relationship.

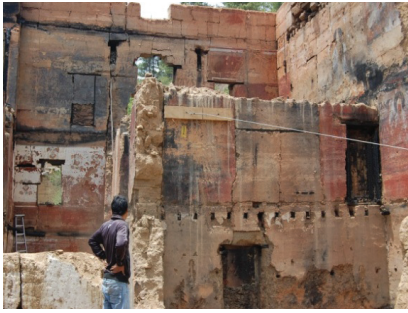
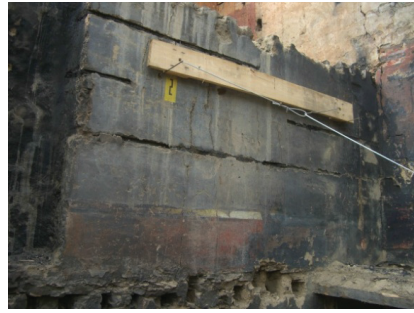
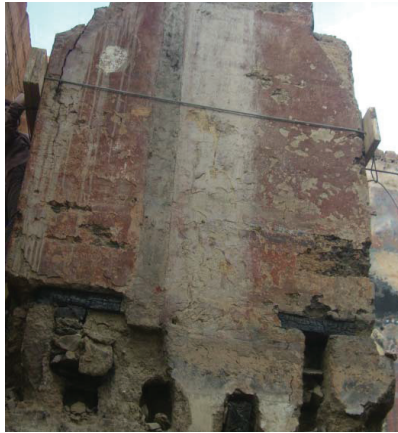
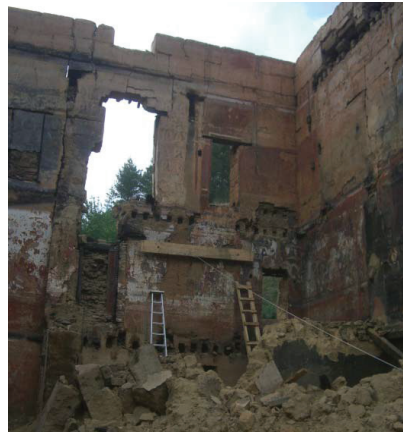
(a) Wall-1 (out-of-plane).

(b) Wall-2 (out-of-plane).

(c) Wall-3 (in-plane).

(d) Wall-4 (out-of-plane).

Figure 8. Overview of rammed earth walls subjected to pull-down test.

The pull-down test on the rammed earth walls at Paga Lhakhang was conducted in the out-of-plane and in-plane directions of the walls shown in Figure 8. The rammed earth walls subjected to the test were designated as Wall-1 to -4. Wall-3 was pulled down in the in-plane direction, and the other walls were pulled down in the out-of-plane direction. The height of Wall-1 was ~6.2m, which was almost from the ground line to the ceiling level of second story, and the width was ~4.1m. The height of Wall-2 was ~5.8m and the width was ~7.4m. The height of Wall-3 was ~6.1m and the width was ~2.3m. The height of Wall-4 was ~11.5m, which was almost from the ground line to the roof level, and the width was ~12.7m. Wall-4 was pulled down at the ceiling level of second story.

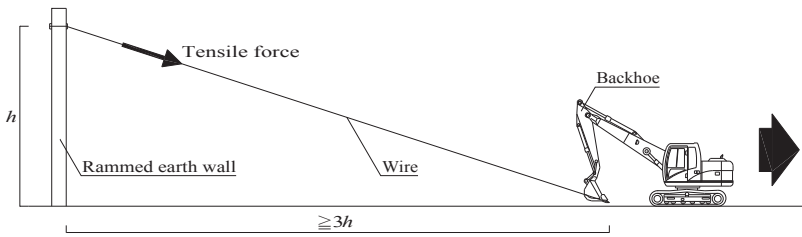
Figure 9. Schematic of pull-down test.

We connected the top of the rammed earth wall and the backhoe by a wire (Figs. 9 and 10). As the backhoe moves backward, the wire pulls the rammed earth wall down. During this time, the wire is subjected to tensile force, therefore rammed earth wall is subjected to component forces, which are divided into the compressive force in the vertical direction and the tensile force in the horizontal direction. To reduce the compressive force on the rammed earth wall, to load more pure horizontal force, and to ensure safety when the rammed earth wall collapses, the horizontal distance between the rammed earth wall and the backhoe was set to at least three times the height of the rammed earth wall ($\geq 3h$) (Fig. 9).

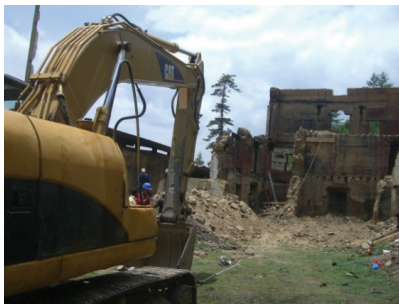
Figure 10. Overview of pull-down test.

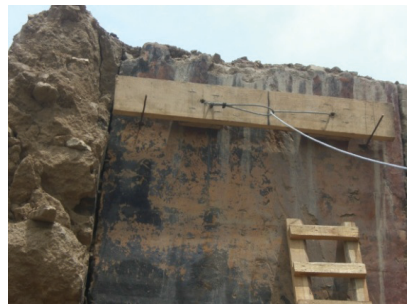
Figure 11. Wooden plate.

To avoid the local failure and to apply a distributed load on the wall, a wooden plate was placed on both the front and the back of the top of the rammed earth wall at the point where we applied the load; a hole was drilled through the wooden plate and the edge of the rammed earth wall for the wire to pass through, thus wrapping the rammed earth wall with the wire (Fig. 11). Wall-4 was pulled with two wires because of wire breakage during the pull-down test. The wire was attached to the forks of the backhoe to pull the rammed earth wall.

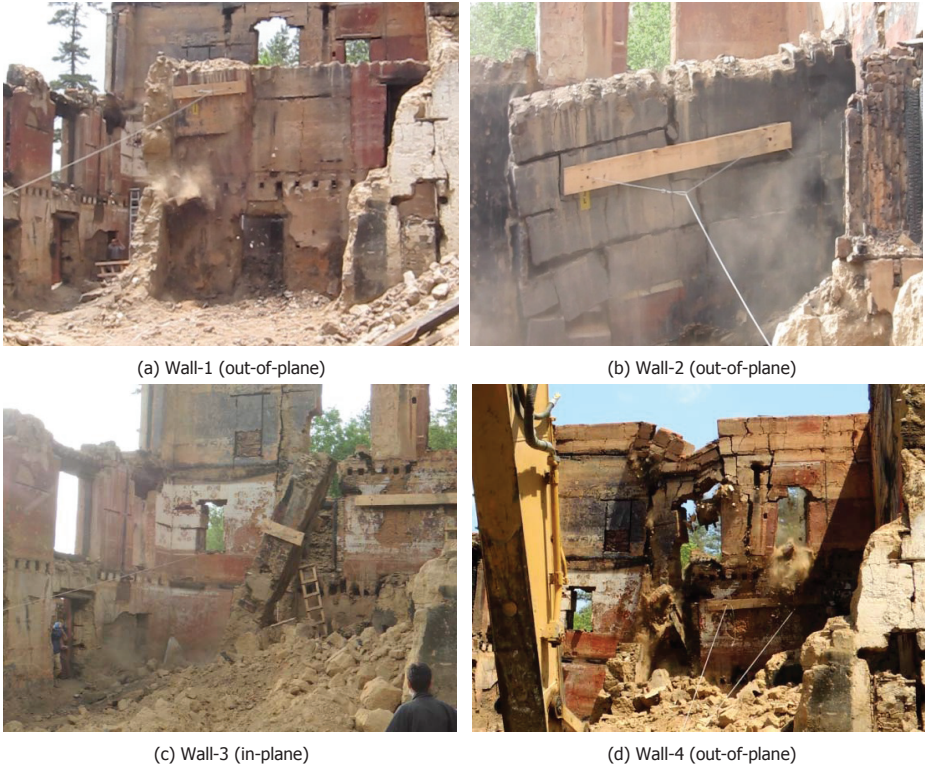
Figure 12. Collapse mode of rammed earth walls.

Figure 12 shows the collapse modes of Wall-1 to -4 and the load–displacement curves are shown in Figure 13. Wall-1 collapsed by the section loss of the rammed earth and restriction effect of the wooden member included inside the orthogonal rammed earth wall. Wall-2 and -4 collapsed by the section loss of the rammed earth caused by joists at the floor level of Paga Lhaxhang. Wall-3 collapsed by sliding at the section loss of the rammed earth. The rammed earth walls showed very small deformation before the maximum load, and then, they suddenly collapsed after the maximum load.

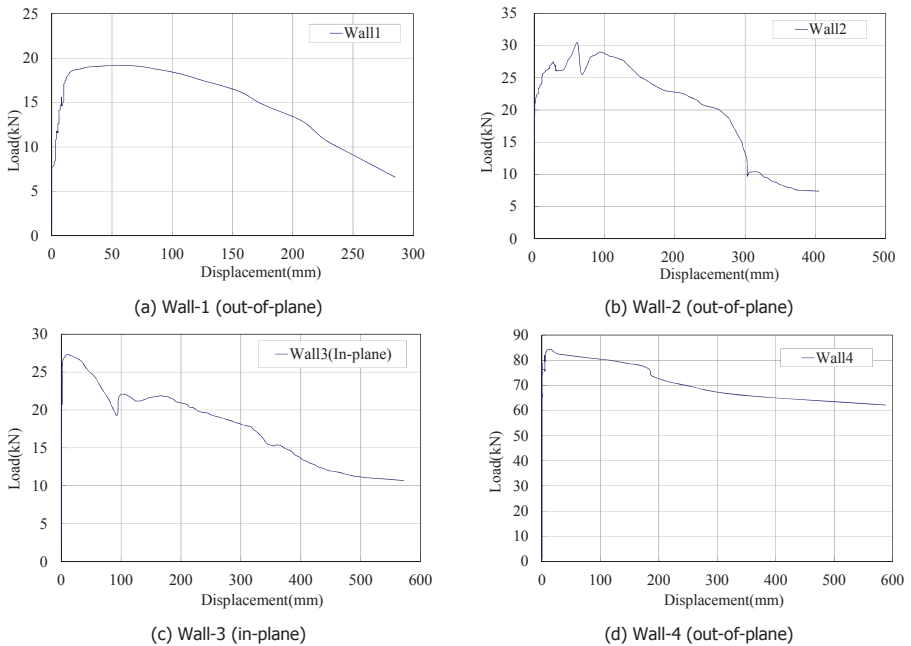
Figure 13. Load-displacement curve.

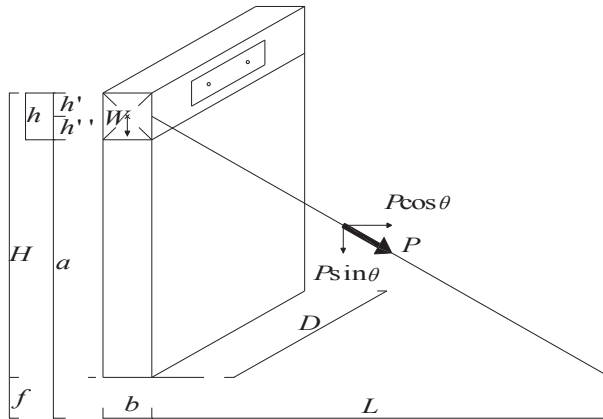
Figure 14. Schematic of force balance.

The tensile stress of the rammed earth wall is estimated from the equilibrium of forces (Fig. 14). The compressive stress by self-weight is calculated as follows:

$$\sigma_{N1} = -\frac{W}{bD} = -\frac{bDh\rho}{bD} = -h\rho \quad (1)$$

where W = weight of upper part of destroyed wall; b = wall thickness; D = wall length; h = distance between top of wall and destroyed section of wall; ρ = density of rammed earth; and σ_{N1} = compressive stress generated by self-weight.

The vertical compressive stress by the component force of the diagonal pulling force is calculated as follows:

$$\sigma_{N2} = -\frac{P \sin \theta}{bD} = -\frac{Pa}{bD\sqrt{a^2 + L^2}} \quad (2)$$

where P = tensile force on wire; θ = angle between wire and ground level; a = distance from ground to destroyed section; L = horizontal distance from wall to backhoe; σ_{N2} = compressive stress generated by component force of diagonal pulling force P ; f = distance from ground to bottom of wall; and H = wall height.

The tensile stress by moment is calculated as follows:

$$\sigma_M = \frac{M}{Z} = \frac{6P \cos \theta \cdot h''}{b^2D} = \frac{6PLh''}{b^2D\sqrt{a^2 + L^2}} \quad (3)$$

where M = moment generated on destroyed section by diagonal pulling force P ; H = distance from top of wall to wire hole; h'' = distance from wire hole to destroyed section; Z = section modulus of wall; and σ_M = tensile stress generated by moment M .

The tensile stress of rammed earth f_t is calculated as follows:

$$f_t = \sigma_{N1} + \sigma_{N2} + \sigma_M = -h\rho - \frac{Pa}{bD\sqrt{a^2 + L^2}} + \frac{6PLh''}{b^2D\sqrt{a^2 + L^2}} \quad (4)$$
