Basalt ropes: a new product for the rehabilitation of historical masonry

A.h.R.T.E. - Architectural heritage Restoration through Tailored Engineering

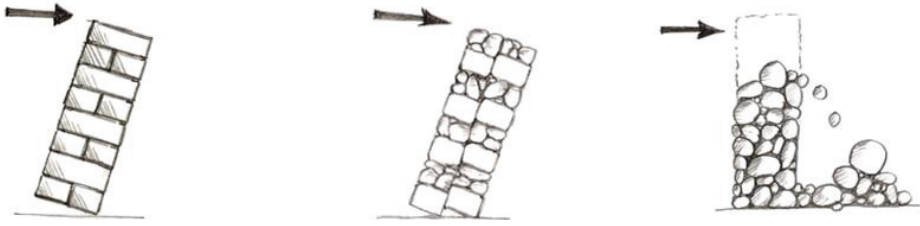
Figure 1. Masonry structural effectiveness directly depends from its quality: good quality masonry subjected to out of plane loads responds like a monolithic body (left), while poor quality masonry is characterized by a chaotic failure (right). For medium quality masonry (center), can be expected a middle behavior.

As shown by several authors (Giuffrè, 1991; Doglioni, 1994), historical masonry buildings subjected to earthquake do not show a global structural behavior. If the building was made through good quality masonry, it has the tendency to split itself in several parts, called macro-elements which respond as single units to seismic action, and for which the main features of the collapse mechanisms are at least approximately known. So historical masonry buildings response to earthquake is the one offered by the number of macro-elements. Once macro-elements and their most probable collapse mechanisms are identified, possible damages can be predicted and countermeasures adopted. Masonry quality defines if this approach could be considered reasonable: in fact only good quality masonry is able to guarantee monolithic behavior. On the contrary, if it has been used poor quality masonry, a chaotic failure has to be expected and it is not right to reasoning about failure mechanism activation. Moreover, also a low earthquake could be enough to determine disastrous collapses, as has been seen in L'Aquila earthquake in the year 2009. Masonry structural effectiveness directly depends from its quality, and when it has been made following "rule of art" prescriptions a masonry can be considered of "good quality" (Fig. 1).

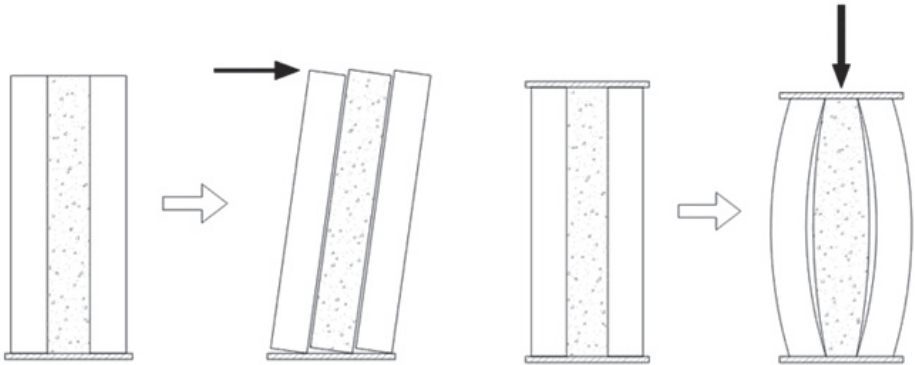
Figure 2. Vulnerability of "three-leaf wall" subjected to horizontal load.

In fact, it could meet problems of buckling of the external shell, due to its slenderness, and of weak resistance to action that could involve out-of-plane mechanisms, due to a global behavior nearest to two thin panels than a monolithic one (Fig. 2).

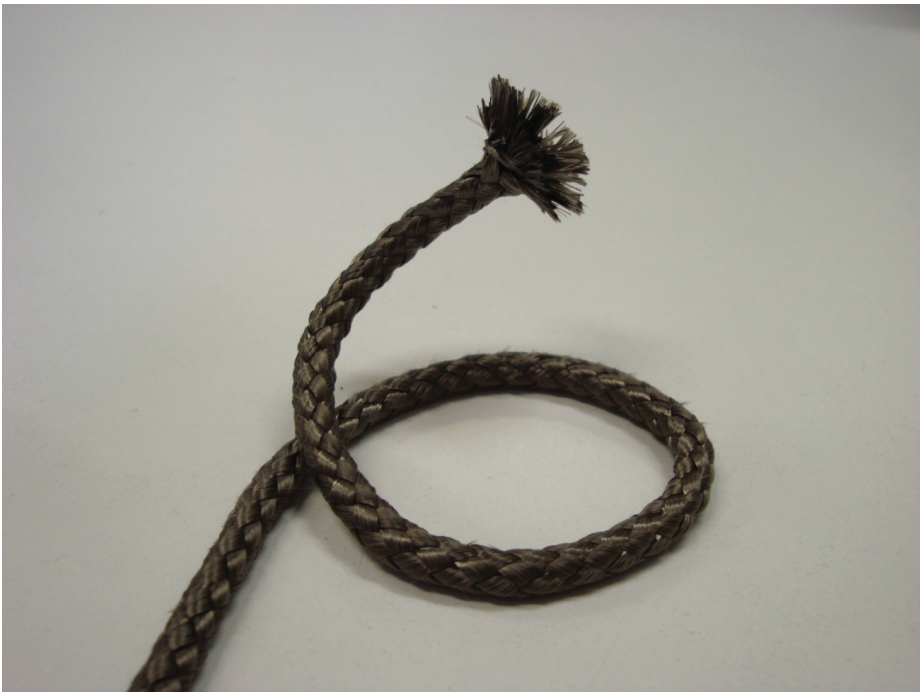
Figure 3. The basalt fibre rope.

Basalt fibre rope mechanical features	
Nominal diameter [mm]	4
Failure load F_{max} [N]	3157.27
Failure strain ϵ_{max}	0.05

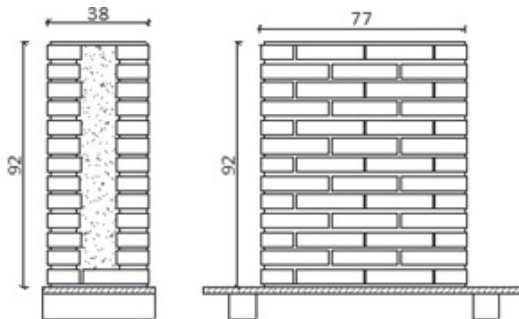
Figure 4. Masonry sample metric survey (values in centimeters).

To assess the effectiveness of proposed technique, laboratory tests have been performed. The masonry reproduced was the "three-leaf wall", where an inner core of rubble material is included between two outer brick shell. 12 "three-leaf" masonry samples have been made, and tested under vertical compression (6) and shear-compression (the others 6) load. The masonry wallets have been made on steel plates (to have the possibility of easily move them) and cured in the same condition for the same time (about 60 days). Specimen dimensions (better presented in Fig. 4) have been chosen similar to the one suggested by the Italian standards on masonry compression test (UNI EN 1052-1) and comparable to the ones used in other analogous experimental experience available in literature (Binda et al., 2006; Vintzileou et al., 2008). Before testing, 8 masonry samples have been reinforced through proposed technique, in particular in 4 of these, BF ropes have been arranged only in horizontal bed mortar joints (reinforcement called "RO", Fig. 5), while in the other 4, BF ropes have been inserted also in vertical bed mortar joints (reinforcement called "RR"). Only 4 masonry samples have been tested in unreinforced condition ("NC"). The experimental program is better explained in Table 2. Figure 6 reports the final aspect of masonry wallets at the end of reinforcing process. Vertical compression and shear-compression tests (performed under load control) have been carried out placing sample into a steel frame (Fig. 7). Forces has been applied through pressure jacks and measured by means of pressure transducers; vertical and horizontal displacements have been monitored by means of transducers placed on the top and on the sides of the wall, in order to measure transverse deformations of wall and separation between exterior leaves and filling material.

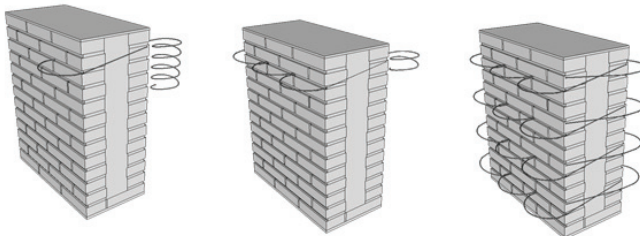
Figure 5. Operative phases for the application of "RO" reinforcement.

The proposed technique aims to connect outer brick masonry shell to exclude buckling failure and to impart monolithic behavior, without modify masonry original aspect. It consists in insertion of basalt fibre ropes in the mortar bed joints previously partially cleared out and refilled with simple mortar only to cover the ropes and restore original appearance and homogeneity. The holes disposition has been chosen following an appropriate and tailored designed path. The main operative phases for a correct execution of the intervention are: (i) execution of crossing hole by means of drill equipped with a bit long as the wall depth; (ii) cutting of the bed mortar joints creating a groove at least 10mm high and about 30-40mm deep

on the two wall faces; (iii) removal of powder or rubble; (iv) placing of a first layer of mortar; (v) placing of the basalt fiber rope; (vi) placing a second layer of mortar over the rope to cover it sufficiently. Respect insertion of steel or FRP bars, as in repointing application, come out the opportunity of working with a lighter and versatile material and able to connect the masonry elements also in the panel depth direction.

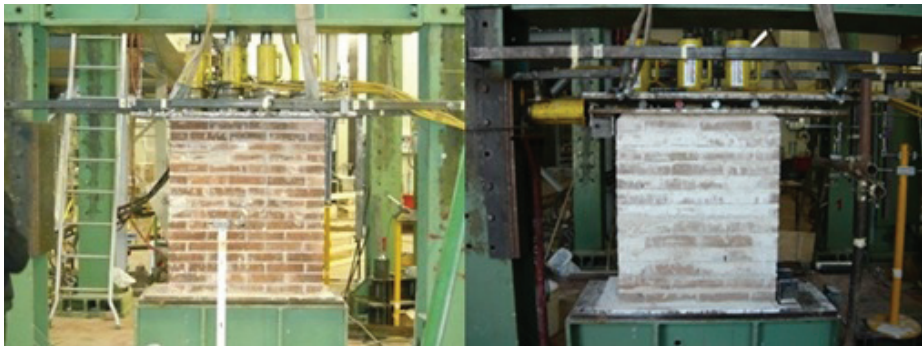
Figure 7. The test device used for vertical compression test (left) and the test device used for shear-compression test (right).

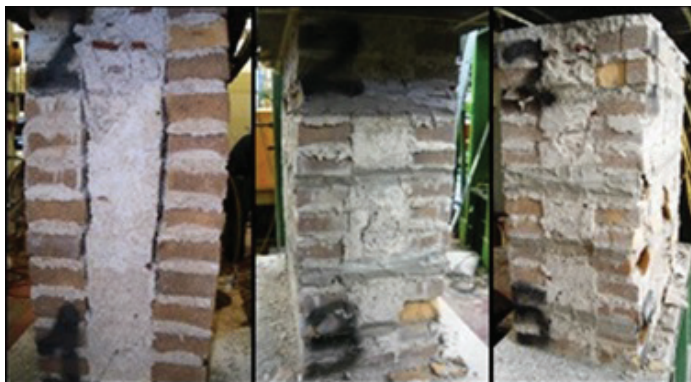
Figure 8. Three-leaf masonry samples after vertical compression tests: on the left the unreinforced ones ("NC"), in the center the ones strengthened through BF arranged only in horizontal bed mortar joints ("RO") and on the right, the ones strengthened through BF arranged both horizontal and vertical bed mortar joints ("RR"). The sample aspect after test shows the effectiveness of the proposed technique.

In this section, the main results concerning the testing of the three-leaf masonry samples are discussed. As predictable, under vertical compression load, unreinforced samples exhibit the same failure mode, characteristic for three-leaf masonry: separation between the interior filling material and the external leaves and buckling collapse of one of them (Fig. 8, on the left). This fact is probably due to the inevitable eccentricity of the applied load. Reinforced samples, instead, exhibit a different failure mode: the external leaves work together to carry the applied load and the failure occurs due to overcoming of material ultimate strength (Fig. 8, in the center and on the right). This fact is well underlined by the cracks appeared on bricks of reinforced samples: only in that cases the materials have been entirely subjected to the stress generated by applied load (Fig. 9).

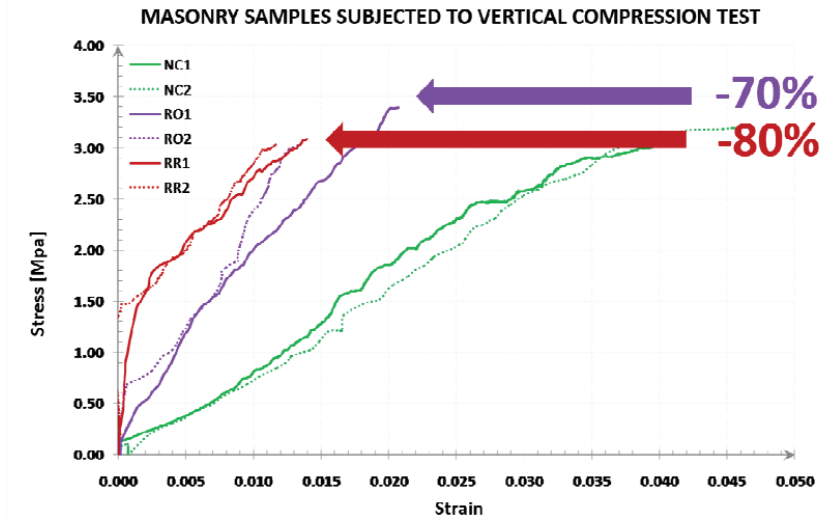
Figure 10. Comparison between stress-transverse strain graphs recorded for three leaf masonry samples subjected to vertical compression test.

Comparing the graph that binds vertical stress and transverse strain (Fig. 10), come out as the intervention, discarding buckling collapse and better exploiting material properties, contributes to impart a monolithic behavior to the masonry panel. In fact, the stitches application is able to reduce transverse strain of 70% ("RO") and 80% ("RR").

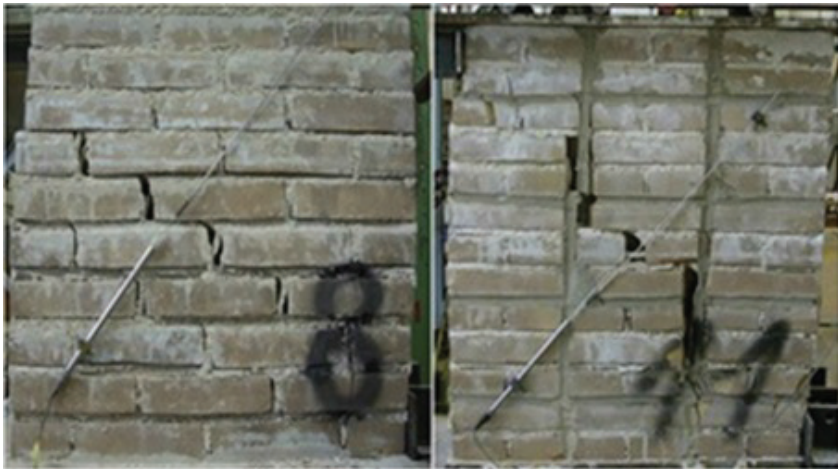
Figure 11. Three-leaf masonry samples after shear-compression test: on the left the unreinforced ones ("NC") and, on the right, the ones strengthened through BF arranged both horizontal and vertical bed mortar joints ("RR").

Also from shear-compression tests come to light that under this kind of load three-leaf masonry has a behavior nearest to several thin panels than a monolithic one. In fact in "NC" samples, it could be seen a crack pattern typical of shear stress (Fig. 11, on the left) and a separation between interior core and outer brick leaf. In this case the "RO" strengthening is not able to produce clear improvements, on the contrary of the "RR" one that seems to be able to modify panel failure mode (Fig. 11, on the right) in the way to sustain a more serious crack pattern, and to improve substantially the system pseudo-ductility (Marcari G. et al., 2007) as can be seen in Figure 12.

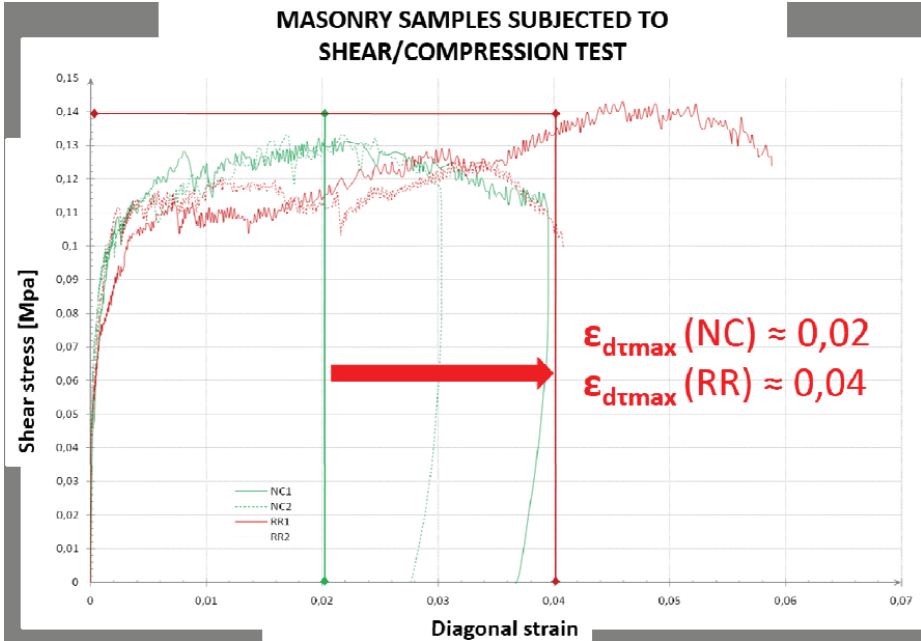
Figure 12. Comparison between shear stress/diagonal strain graphs recorded for three leaf masonry samples "NC" and "RR" subjected to shear compression test.
