In-situ monitoring of thermal refurbishment on pre-1919 properties in Scotland

This work describes the use of in-situ monitoring techniques to establish the building performance of pre-1919 traditionally constructed buildings and evaluate different thermal refurbishment strategies using component U-values as a recognised indicator of building envelope performance. The buildings monitored were of traditional construction (solid wall), some of which were listed or in a conservation area, constructed from lime-bonded rubble or ashlar, typically circa 500 mm thick, with natural slate or tile roofs, timber doors and single glazed windows. In-situ pre-intervention U-values were obtained after monitoring each building component constituting the existing building envelope and again at post-intervention; where insulation materials were added at varying interfaces. Using the improvement data two case studies were modelled using the UK Standard Assessment Procedure (SAP) software; showing that significantly reduced levels of building heat loss and carbon dioxide emission were achieved after thermal rehabilitation.

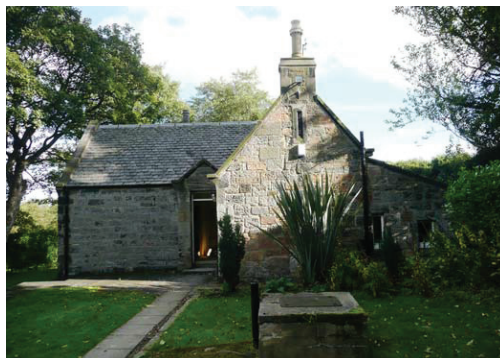
Figure 3. Wells O' Wearie facing north west.

Wells O' Wearie cottage is a small single storey detached building dating from the early 19th century, with an east - west orientation. The cottage is constructed of sandstone rubble, bound with lime, and finished with ashlar quoins and margins. The property is owned and managed by Historic Scotland (Curtis & Jenkins, 2012). It is located in Holyrood Park area of Edinburgh (Scotland) on a sheltered site below the road level (Fig. 3). Pre-intervention monitoring took place during October 2010 whilst the property was unoccupied.

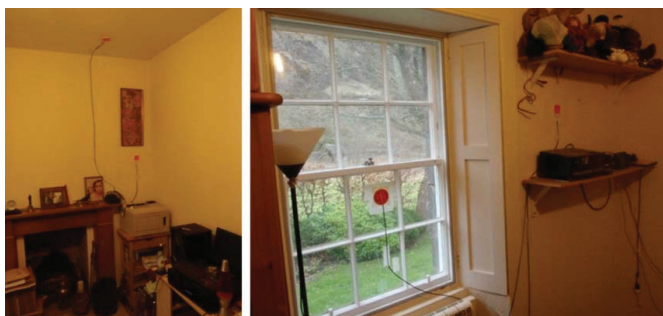
Figure 4. Heat flow mats on north east wall & window.

Heat flow mats were positioned to monitor heat transfer through the walls, floor, ceiling and window glass. Four heat flow mats were attached to three walls during the pre- and post-intervention stages. Two heat flow mats were added to the north wall on either side of the window, a single mat was added to the west wall and one to the east wall, all attached to the internal surface of the wall. A heat flow mat was also added to the centre of the window (Fig. 4). Data was logged at two minute intervals over a period of three weeks. The average outdoor temperature recorded was 8°C with a relative humidity of 75%. Internally the average temperature was 15°C at 49% relative humidity. Post-intervention monitoring took place between February and March 2012 during a three week period. The heat flow mats were reinstated on the same locations as the pre-intervention period; average readings showed: internal temperature of 18°C at 60% relative humidity and external temperatures of 9°C and 80% relative humidity.

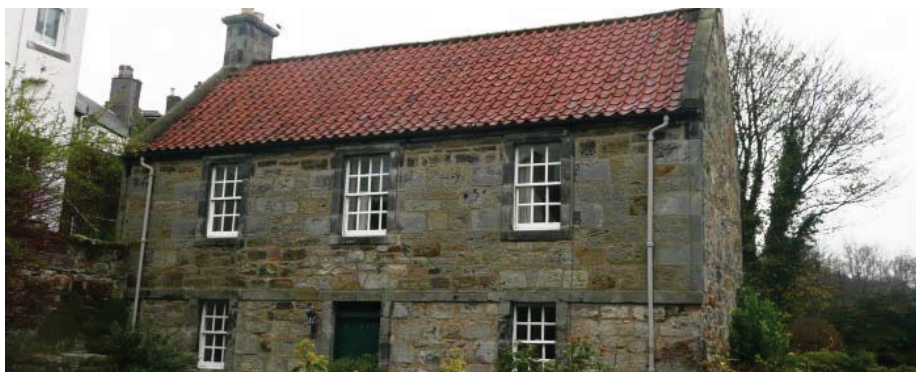
Figure 6. Front elevation of Wee Causeway Cottage.

The building is a detached cottage referred to as 'Wee Causeway' (Fig. 6), located in the village of Culross, Fife, cared for by the National Trust for Scotland.

The original fabric dates from the mid-18th century. It consists of a sandstone rubble masonry wall bound with lime, although has been re-pointed with cement in several areas. Internally the walls in the ground floor rooms are lined with lath and plaster, others have plaster 'on the hard' (i.e. directly onto the masonry). All rooms had a standard cornice detail in place (Curtis & Jenkins, 2013). It has a pitched pan-tile roof common to the east coast of Scotland and the windows are single glazed sash and case.
