The demolition of the restaurant inside Queen's Fort of Tarragona (Spain)

British General James Stanhope reached Tarragona in 1709. He wanted to establish a naval base, in order to give military support to Archduke Charles of Austria in his dispute for the throne of Spain with Philip V. The "Fortí de la Reina" (Queen's Fort) is part of the overall project for the city fortification, led by Austrian and British; its position defended the northeastern end of Miracle Beach. Between 1988-1992 a large restaurant (about 2500 m²) was built within the walled perimeter of the Fort; it recreated a Romanesque cloister using GRC panels (glass fiber reinforced concrete), an architecture totally incongruent with the austere 18th century military structure in which it was housed. After various legal disputes, in 2007 a court ordered the demolition of the restaurant to return, as much as possible, the Queen's Fort to its previous state. In this paper we describe this demolition work.

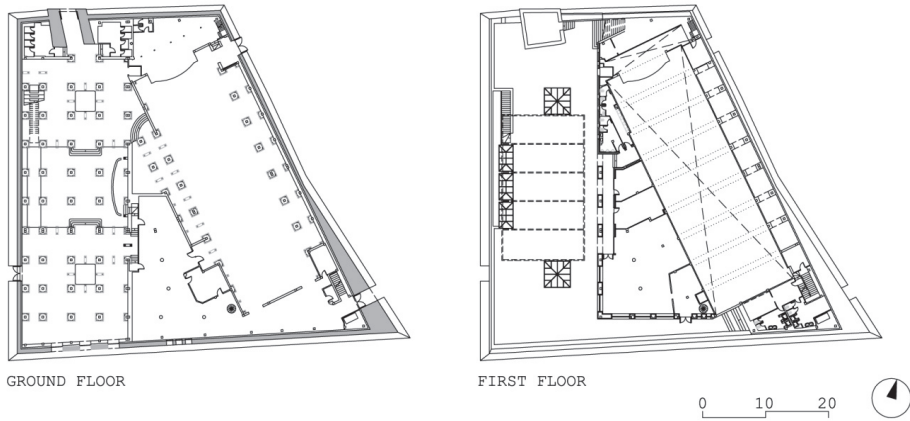
- The original section of the wall was altered in order to increase the inner surface of the enclosure. Inner embankments were emptied, and concrete blocks retaining walls were constructed to stabilize the outer sloping masonry wall.
- Various openings in the wall were performed: six windows and three emergency exits.
- Exterior walls were raised to disguise the upper floor volume.

Figure 3. The restaurant within the walled perimeter of the Fort.

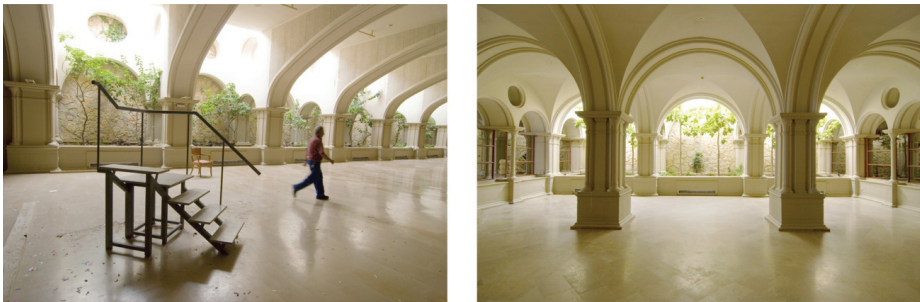
Figure 4. Restaurant interior with 'Romanesque style' decoration.
