International Journal of Heritage and Sustainable Development

Vol. 4, No. 1, 2015, pp. 183-191

## Assessment of the stability conditions of an ancient stone masonry tower

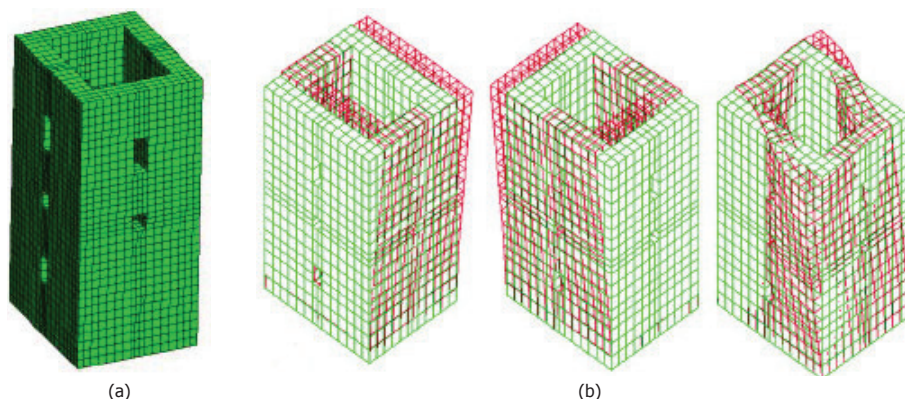
To calibrate the material properties of the model, a dynamic modal identification test was carried out in situ. A preliminary linear analytical model was done and the material properties were assumed taken into account the preliminary lab test on the granite and the fact that the wall was modeled as a continuum element (Fig. 10a).

The dynamic test was performed using the ambient vibration caused by the wind, which allowed the determination of the three principal mode shapes (Figure 10b) and Table 1. These mode shapes allowed to obtain the material properties for the numerical model, namely the elastic modulus of 1GPa. The other properties remained unchanged (Poisson's ration of 0.2 and density of 2000 kg/m<sup>3</sup>).

Figure 10. FEM model for the tower: (a) continuum model and (b) mode shapes from the modal identification analysis.

After calibrating the model, deflections and stresses were checked in an updated linear elastic analysis. As handcheck calculations anticipated, low compressive stresses were found in the results, where maximum compression stresses values of approximately 1MPa were obtained. Figure 11 shows the stress level in all the tower. It can be observed that maximum tensile stresses occur mainly around openings.
