Structural repair of decayed old timber end beams

Jorge M. Branco

Timber end-beams represent portions with high risk of degradation due to biotic agents like rot fungi and insect attacks. Different repair techniques are available, with distinctive level of intrusion, but the substitution of the damaged part with a solid wood prosthesis is a methodology well accepted. The connection of the prosthesis to the original member can use screws, binding strips, stirrups and glued-in rods. Despite it is possible to find different case studies in literature, no study is known for the case of Maritime pine beams and prosthesis connected with glued-in steel rods. This work intends to fill this gap by presenting an experimental campaign aimed to evaluate a technique to repair timber end beams through the use of wood prosthesis connected to the original element by glued-in steel rods. For comparison purposes, the addition of new timber elements connected by screws is also evaluated as it represents a current practice in Portugal.

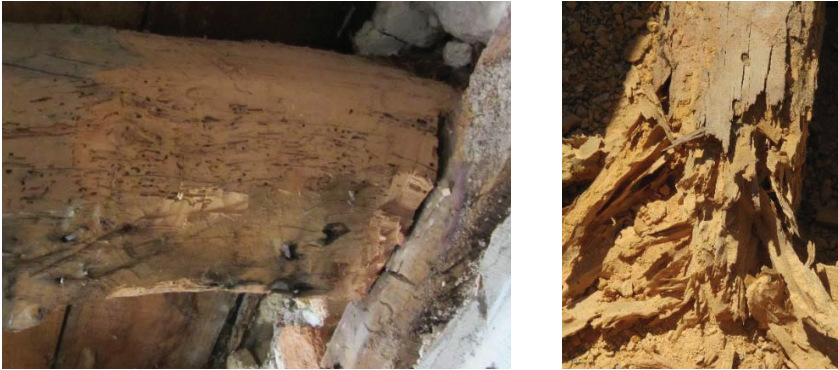
Figure 1. Examples of decayed old timber end beams.

moisture cannot be evaporated because of lacking in ventilation, the suitable conditions for biotic attacks are established (Carll and Highley, 1999), and therefore degradation of end-beams can be expected (see Fig. 1). This fact is well known among structural restorers and engineers familiar with timber. The first considerations about the effects of moisture content onto the end-beams were due to Vitruvio (Barbaro, 1997), whereas the suggestion of preparing aerated supports for hosting beam heads were firstly attributable to Leon Battista Alberti (Portuguese et al., 1966).

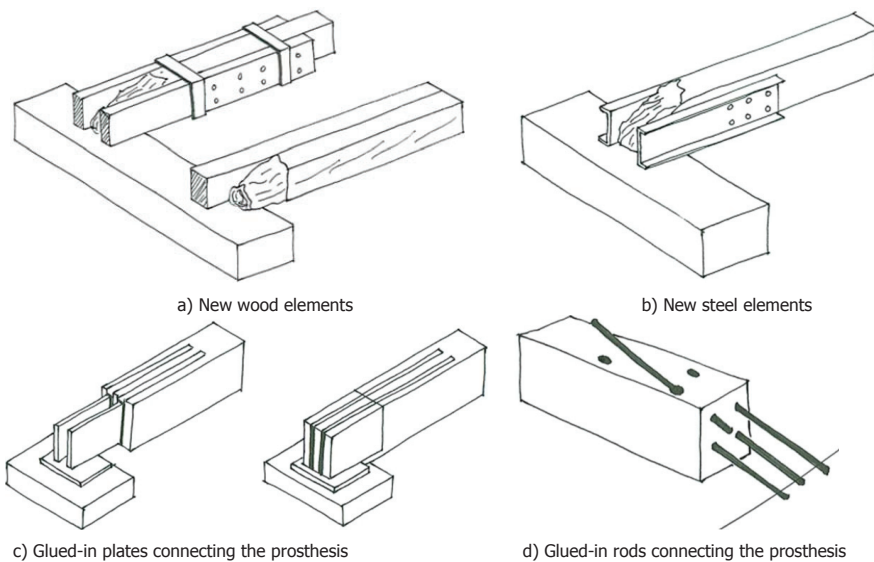
Figure 2. Examples of possible repairing techniques based on the addition of new elements or wood prosthesis.

Nowadays, several examples of techniques and methods can be found in literature for the repair and reinforcement of timber end beams (Tampone, 1996; Arriaga et al., 2002; Appleton, 2003). In fact, since the early seventies, diverse companies have purposed materials and techniques to repair decayed timber elements. It is possible to identify two distinct groups of techniques: one using wood based materials or steel elements and the other based on the so-called new materials as fiber reinforced polymers (FRP) and resins. Different levels of intrusion can be identified in the case studies reported in literature but all interventions considers the repair of individual structural elements as a mean to restore the support that has been lost. The simplest intervention consists in the substitution of the decayed part with a new element which can be made of wood (Fig. 2a) or in steel (Fig. 2b). Other approaches regards the substitution of the damaged part with a solid wood prosthesis connected to the remaining part of the element using glued in plates (Fig. 2c) or rods (Fig. 2d).

When the aesthetic value is not important, the connection of the prosthesis can be external, using nailed or screwed plates. However, usually, prosthesis are connected to the undamaged part of the element through glued-in plates or rods. Plates and rods can be in FRP (glass, carbon and aramid) but the steel ones are the more appreciated due to their reduced cost. The use of wood prosthesis become well accepted mainly due to their low intrusion level, simplicity and good aesthetic value.

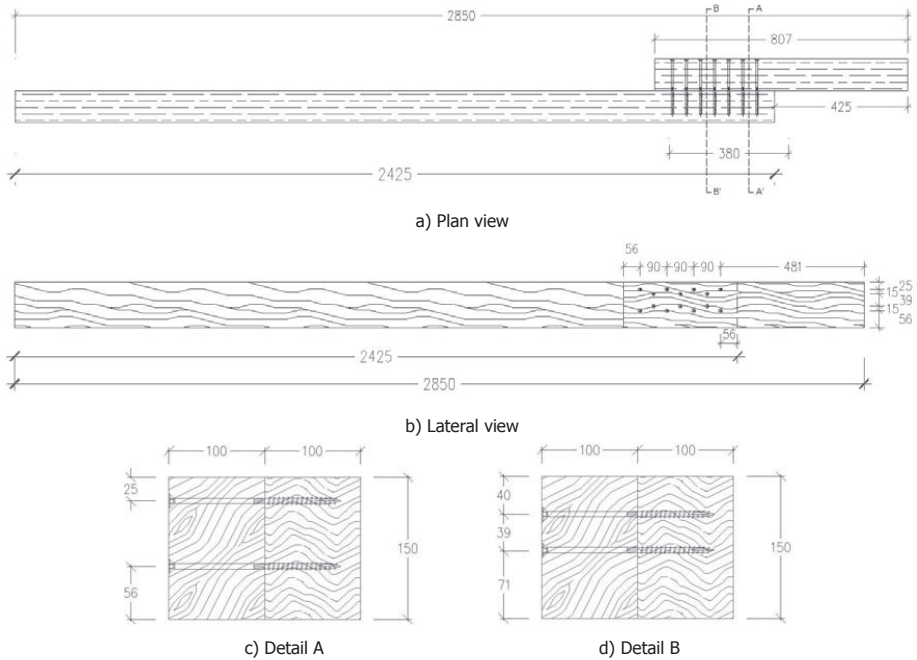
Figure 4. Specimens representing the repair technique based on one new timber element (dimensions in millimeters).

In the case of the repair technique based on the use of new timber elements, the effective cross-section was reestablished by one new element of $100 \times 150 \text{ mm}^2$ (Fig. 4) or two new elements of $50 \times 150 \text{ mm}^2$ (Fig. 5), in the case of specimens *O* and *T*, respectively.

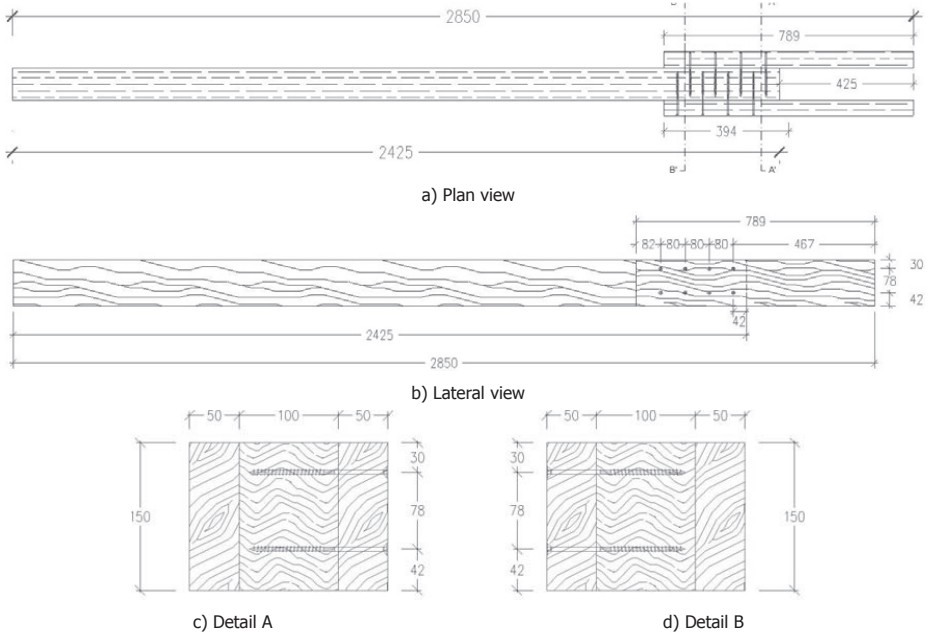
Figure 5. Specimens representing the repair technique based on two new timber elements (dimensions in millimeters).

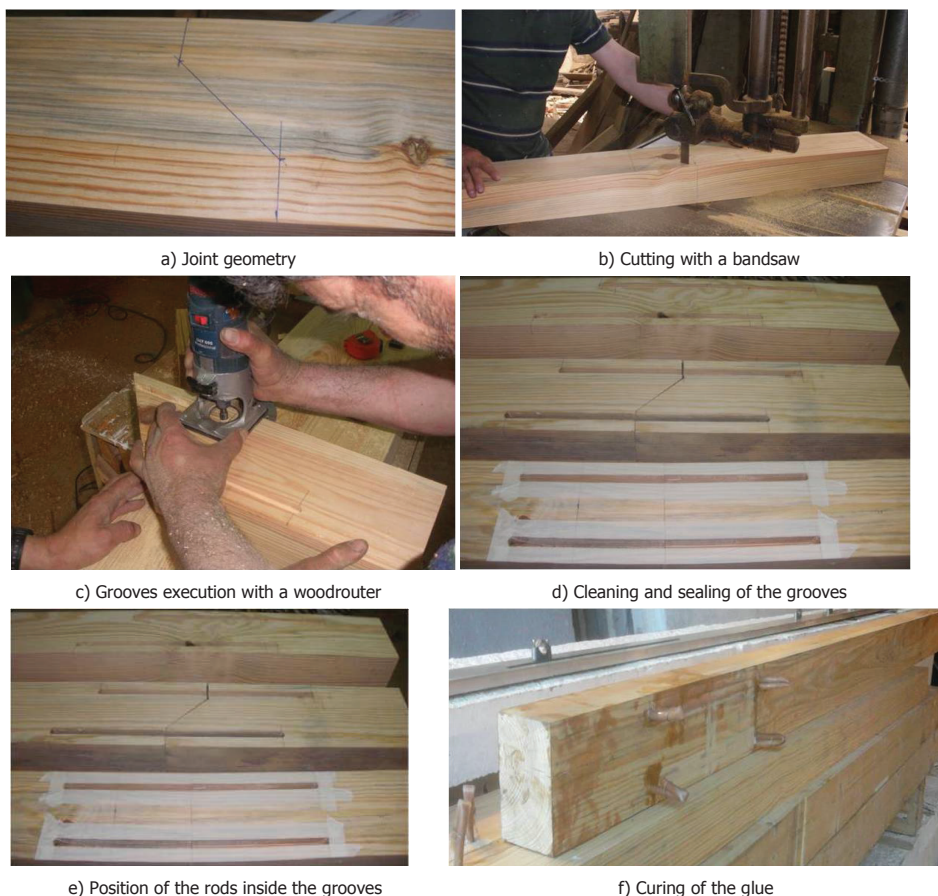
Figure 6. Main steps in the specimens repaired with timber prosthesis.

All specimens have been built by AOF – Augusto de Oliveira Ferreira & CA, Lda, in their own carpentry in Braga, applying the best practices developed more than 50 years of extensive field activity of intervention on existing timber structures. Specimens have been produced and after 10 days they have been transported to the Structural Laboratory of University of Minho in Guimarães. As example, Figure 6 shows the main steps in the production of the specimens used to evaluate the series GM.

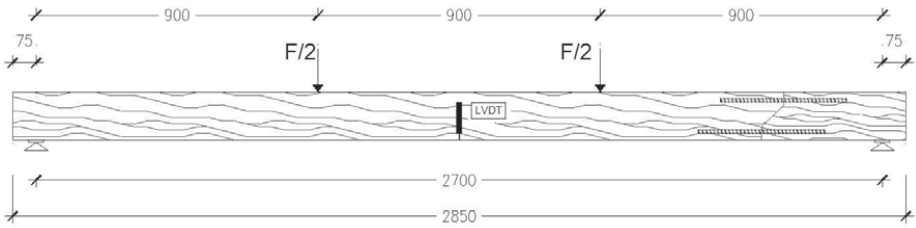
Figure 7. Test setup adopted (dimensions in millimeters).

The four-point bending tests were conducted with reference to EN 408:2010. Those tests use a piece simply supported with a span of 18 times the depth with the loads points placed on the third of the span, as it is shown in Figure 7. The deformation at the mid-span was measured through one linear voltage displacement transducer (LVDT).

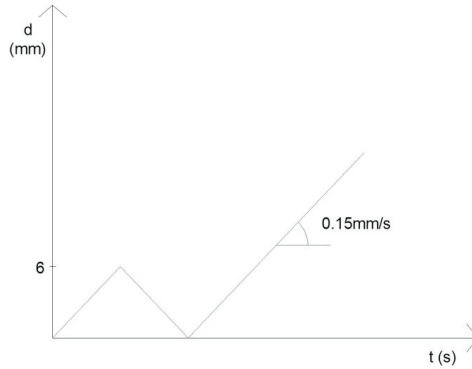
Figure 8. Load procedure adopted.

Displacement control was used for the tests under a displacement rate of 0.15mm/s. The load procedure adopted consisted in a recommended first load and unloading cycle after which the displacement was incremented until failure. The displacement rate adopted was defined in order that the maximum applied load was reached in 300 ± 120 s after the load and unloading cycle. Figure 8 presents the load procedure adopted for all tests performed.

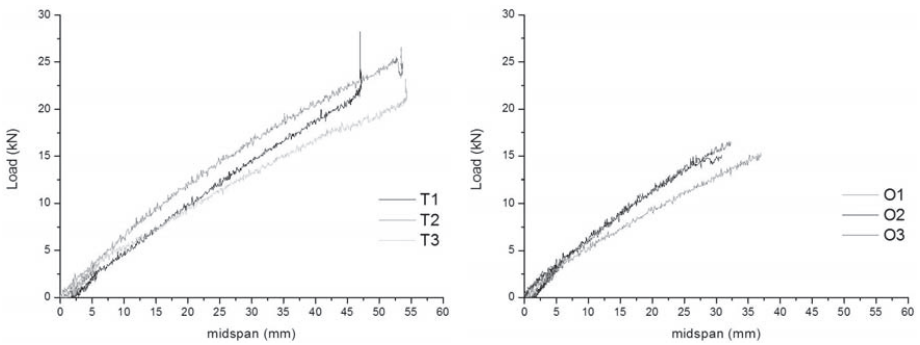
Figure 9. Experimental load-midspan displacement obtained for the series *O* and *T*.

In a first approach, the results of the tests performed are analyzed based in the maximum load value (F_{max}), the bending moment acting in the joint (M_j), the bending stress reached by the specimen in the zone of failure (σ_m) and the failure mode observed (Table 2). Moreover, the experimental load-displacement curves registered are depicts in Figures 9 and 10.

The efficiency of the repairing techniques for decayed timber end beams based in the use of new timber elements screwed to the original, was limited. In fact, due to the large de-formation demonstrated by the specimens tested within series *O* and *T*, the load-carrying capacity of these specimens is inferior to the expected value. In particular, the joint of specimens of series *T* have showed a behavior similar to a hinge (Fig. 11b). In other hand, the specimens of series *O*, with only one new timber element, have failed by wood splitting (Fig. 11a) due to tension stresses perpendicular to the grain that occurred in the row of screws located in the tension side (below the neutral axis). Those stresses could be prevent by local reinforcements but, it is important to point out that the geometry of the cross-section selected, with a reduce height, promotes this brittle behavior.

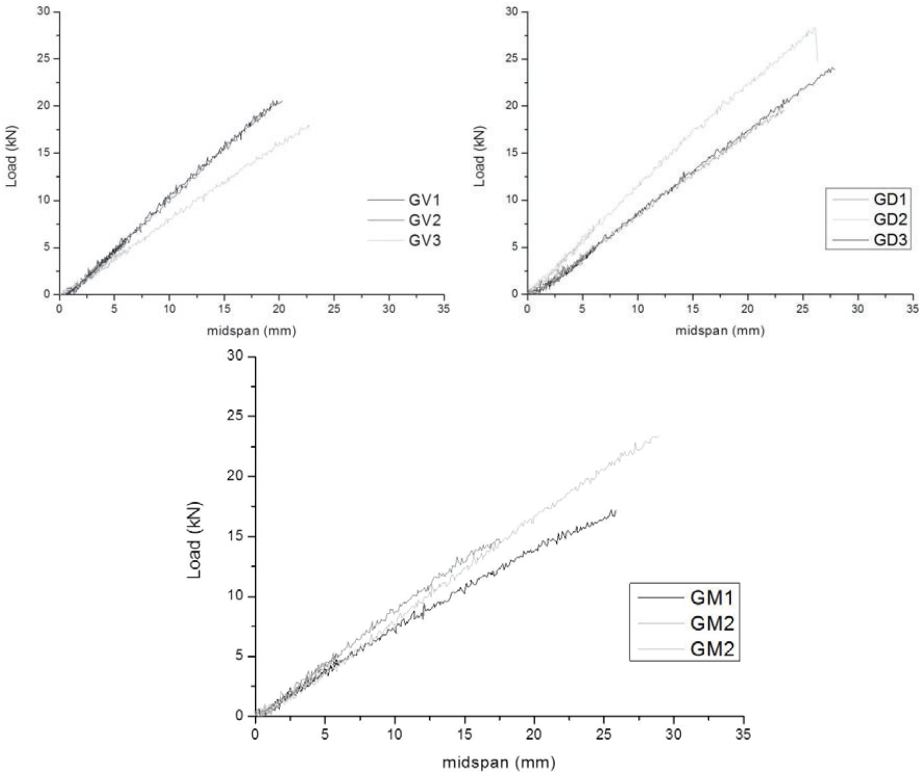
Figure 10. Experimental load-midspan displacement obtained for the series *GV*, *GD* and *GM*.

As general comment, it is possible to identify the good homogeneity demonstrated by the tests results in terms of F_{max} , stiffness and failure mode within each series of specimens. The few deviation resulted from the presence of natural defects, namely the large knots characteristics from the Maritime pine. Comparing the repairing techniques based in the use of new timber elements screwed to the original one, the specimens of series *T* with two new elements, presented lower values for F_{max} , but the large deformation presented by the joint in this series, leading to a significant rotation of the joint, has limited the load-carrying capacity of the specimens. Between the series using timber prosthesis, the one with the diagonal joint (*GD*) has reached the higher values for F_{max} .

Analyzing the results obtained in the series defined to evaluate the possibility to use timber prosthesis connected by glued-in steel rods with different joints geometries, the behavior observed for this repairing technique is encouraging. First, the design method calibrated based in previous exploratory tests seems appropriate as it was possible to obtained in 8 of the 9 specimens tested, a failure in the joint by withdrawal of the steel rod (Fig. 12). This failure could be easily avoid by increasing the anchorage length of the steel rod. However, the glued-in steel rods joint were design assuming the methodology purposed by (Pizzo et al., 2013) and calibrated through exploratory tests, assuming a maximum stress value of 18MPa corresponding to the strength class C18 defined by EN 1912:2004 for the Maritime pine. In all

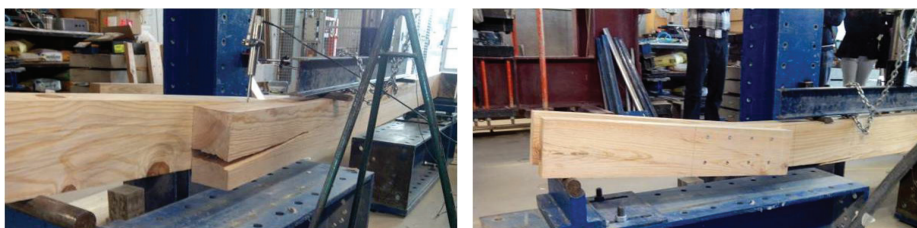
a) Wood splitting in series *O*b) Rotation of the joint in series *T*Figure 11. Failures modes observed in specimens of series *O* and *T*.

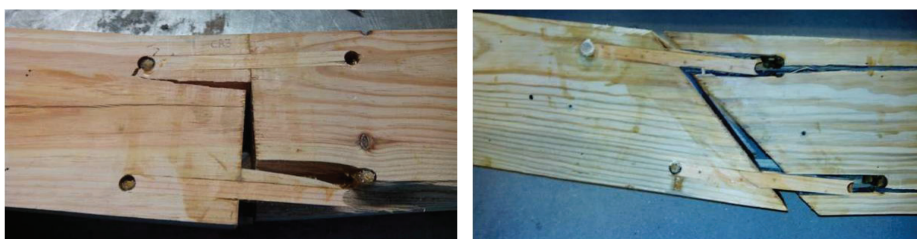
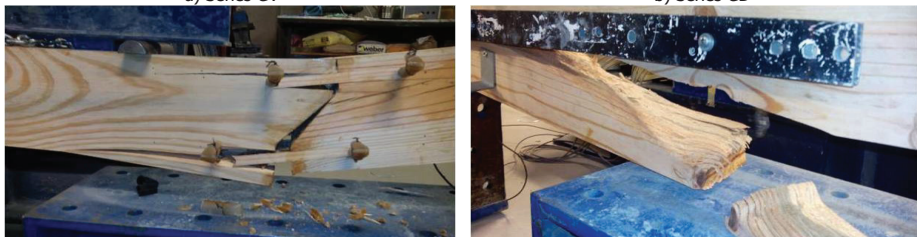
a) Series *GV*b) Series *GD*

c) Series *GM*d) Wood failure of specimens *GM1*Figure 12. Typical failures modes observed in specimens of series *GV*, *GD* and *GM*.
