International Journal of Heritage and Sustainable Development

Vol. 4, No. 1, 2015, pp. 75-87

The "restitution" of the castle of Colloredo di Monte Albano (Udine, Italy)

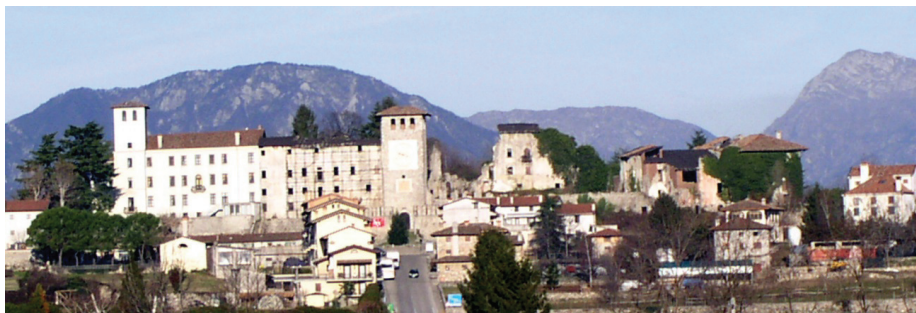
Figure 4. Present view of the South front of the castle.

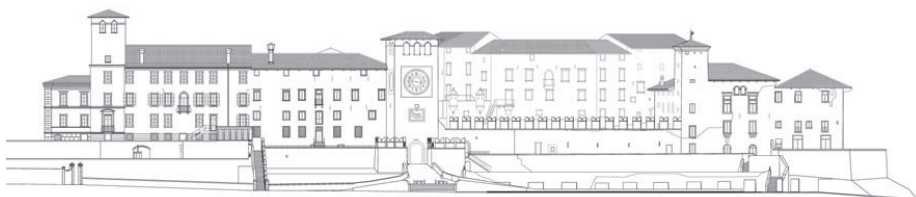
Figure 5. Project elevation of the South front.

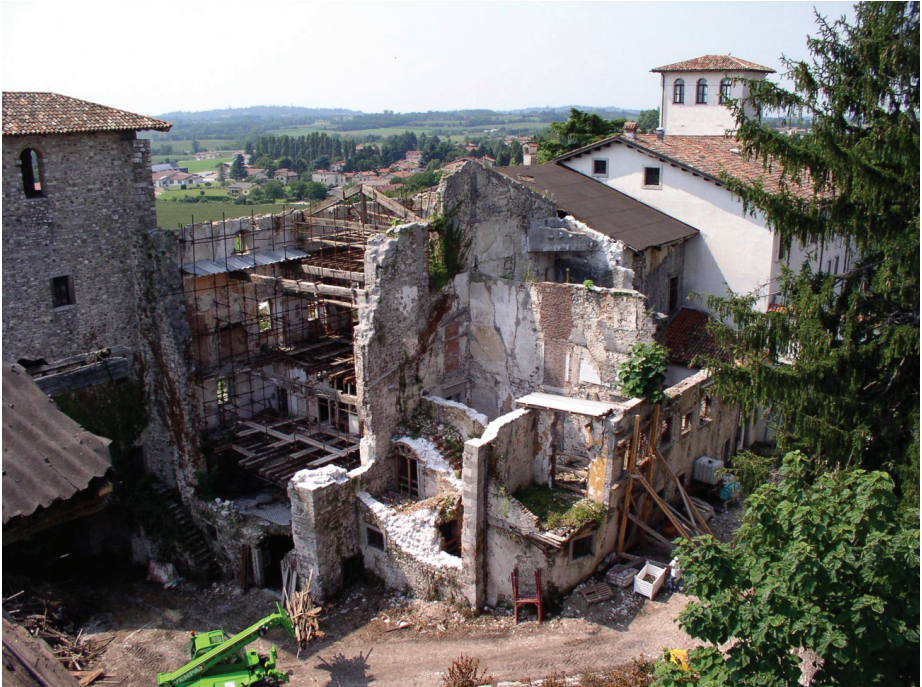
Figure 8. The Nievo wing, present state.

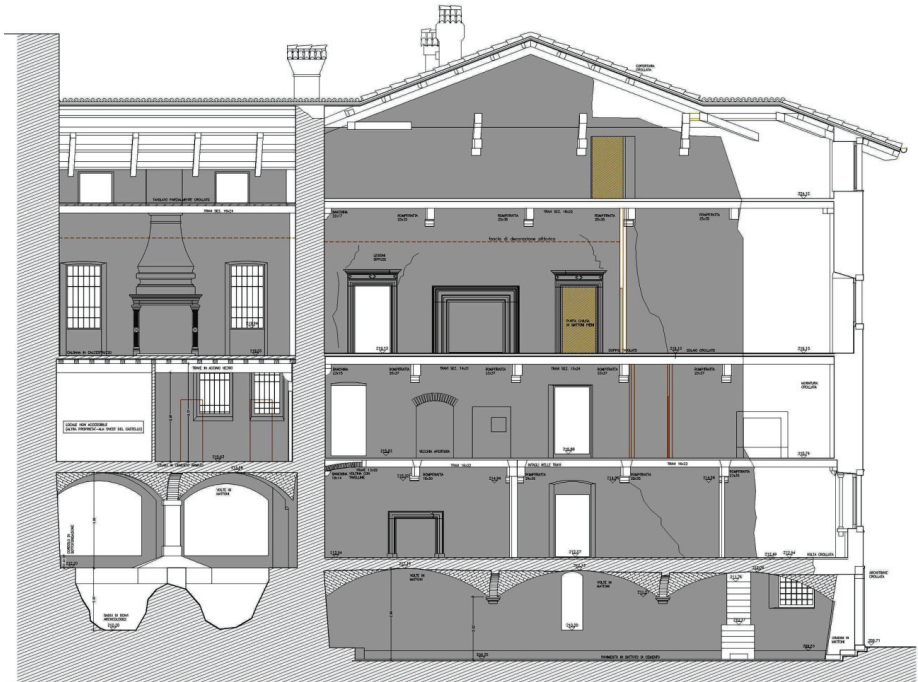
Figure 9. Survey of the Nievo wing: in grey the portion still existent, in white the parts destroyed by the earthquake.

In the plans, elevations and sections were highlighted with proper graphic the remaining parts, the parts and elements that existed before the earthquake, the safety interventions made after 1976, such as the masonry used for closing the openings and the coverings and shorings.

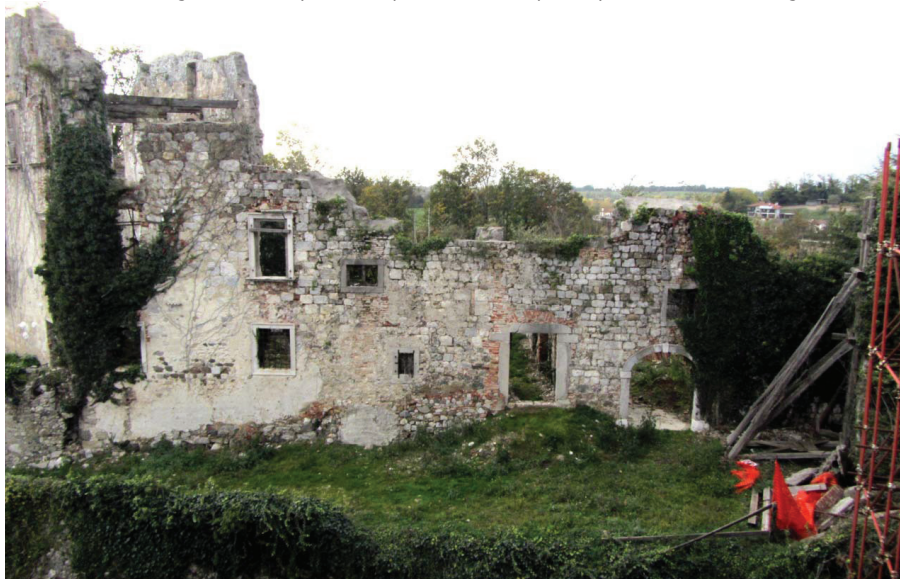
Figure 11. The East front of the Keep, present state.

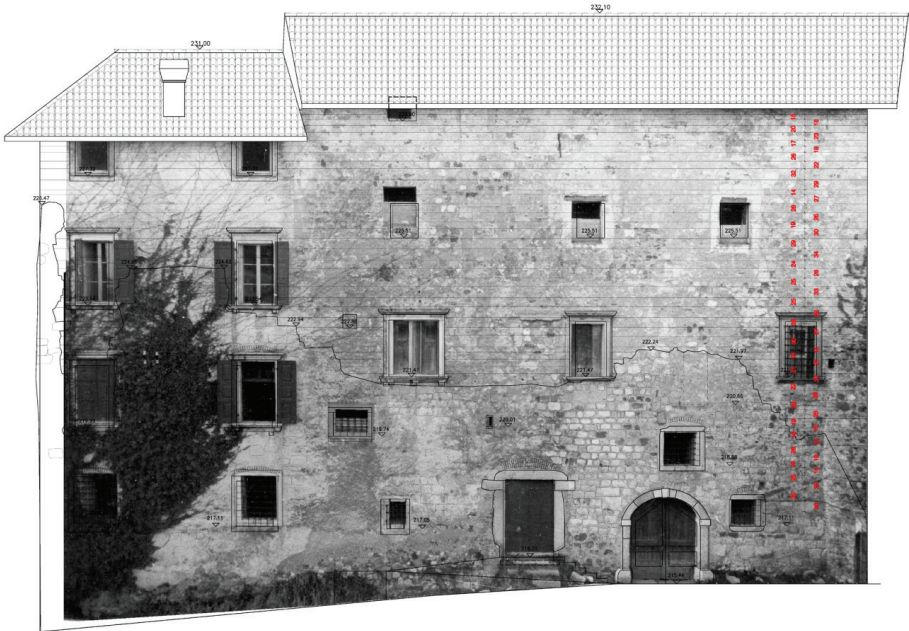
Figure 13. The East front of the Keep: the survey overlaid on the old photograph, with the indication of the height of the stone ashlars in the part to be rebuilt.

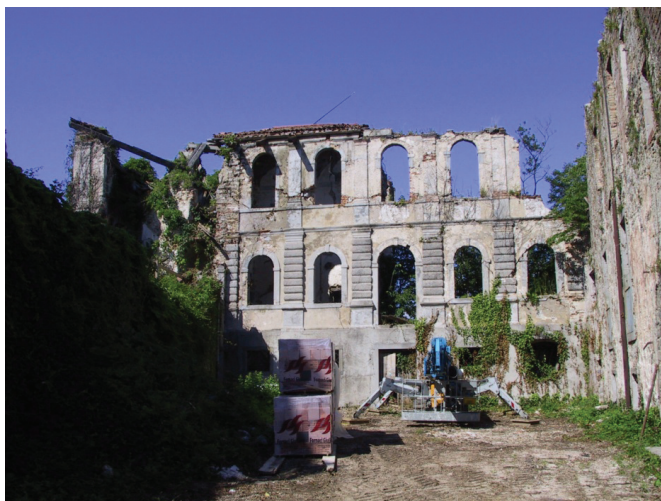
Figure 16. The west front of the East wing after the earthquake.

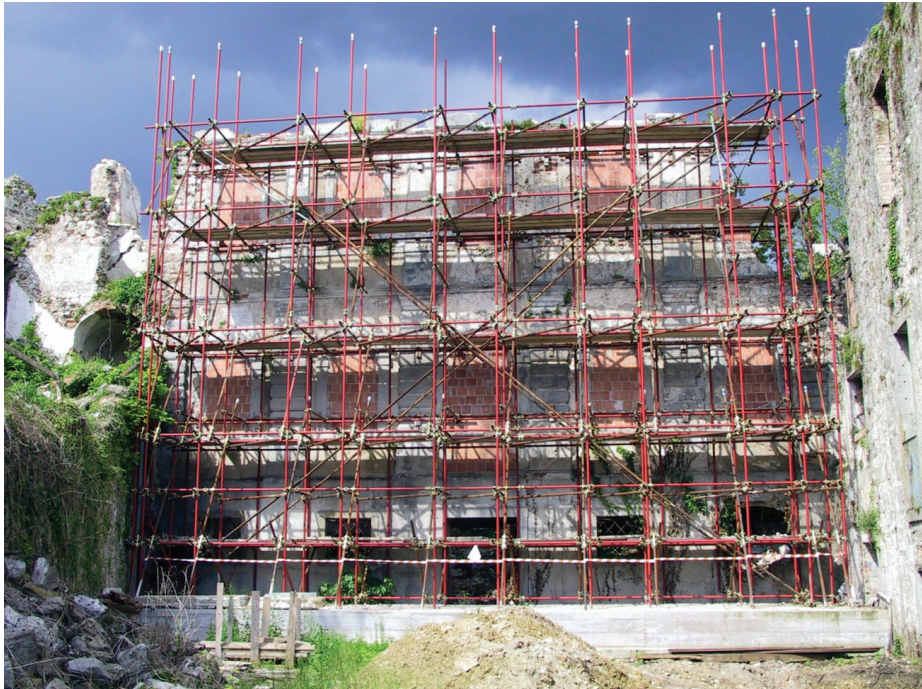
Figure 17. The west front of the East wing, present condition.
